FINAL REPORT

AAIU Synoptic Report No: 2007-010

| Aircraft Type and Registration: | Beech 65-A90 King Air, N712DB |
| Location: | Ireland West Airport Knock |

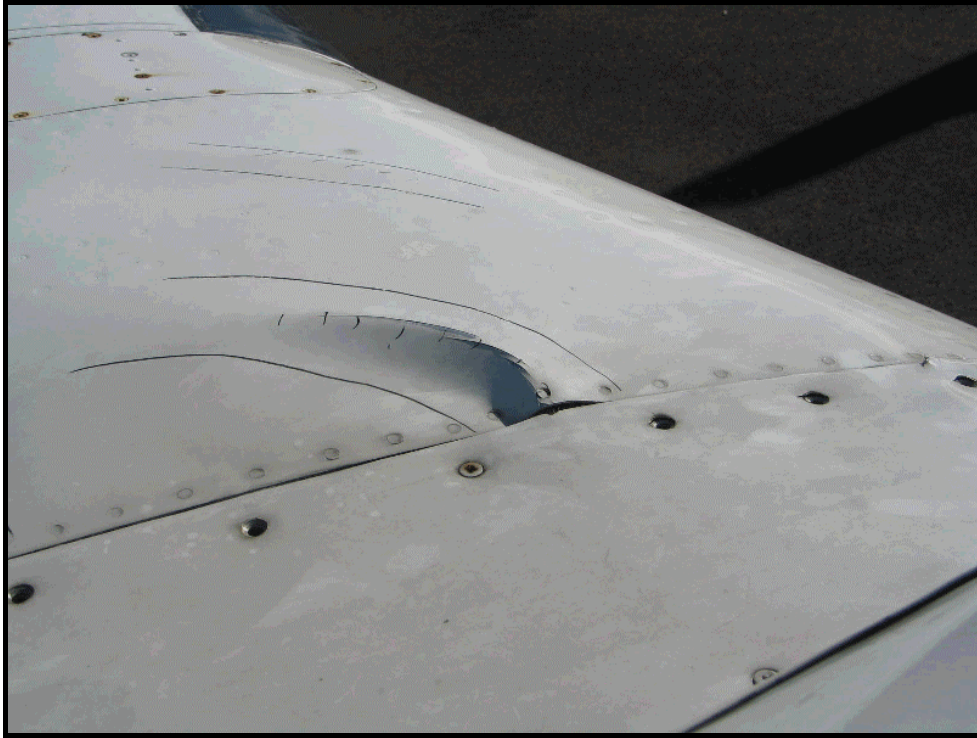
The skin on the top wing surface of both port and starboard wings was found buckled at the outer panel joint (**Photo 1**). The outer panel joint is a production joint, just outboard of the engines, where the outer section of the wing is bolted to the stub wing section. In addition ripples on the upper skin of both wings extend outboard from the joints (**Photo 2**).

The AAIU contacted the manufacturers of Beech Aircraft, the Raytheon Aircraft Company, who stated that the wing damage is representative of both excessive G and over speed. They estimate that the aircraft was subjected to at least 4.5 G. Based on the damage signatures on the wings, they indicated that both horizontal stabilizers would likely exhibit some twisting along their spans.

The skin buckling at the outer panel joint on top wing surface is more significant on the port (**Photo 1**) than the starboard wing. This is consistent with concurrent application of right roll and high G. This buckling is termed “compression buckling” and is caused by wing overload.

Photo 1
Buckling on port wing at outer wing panel joint

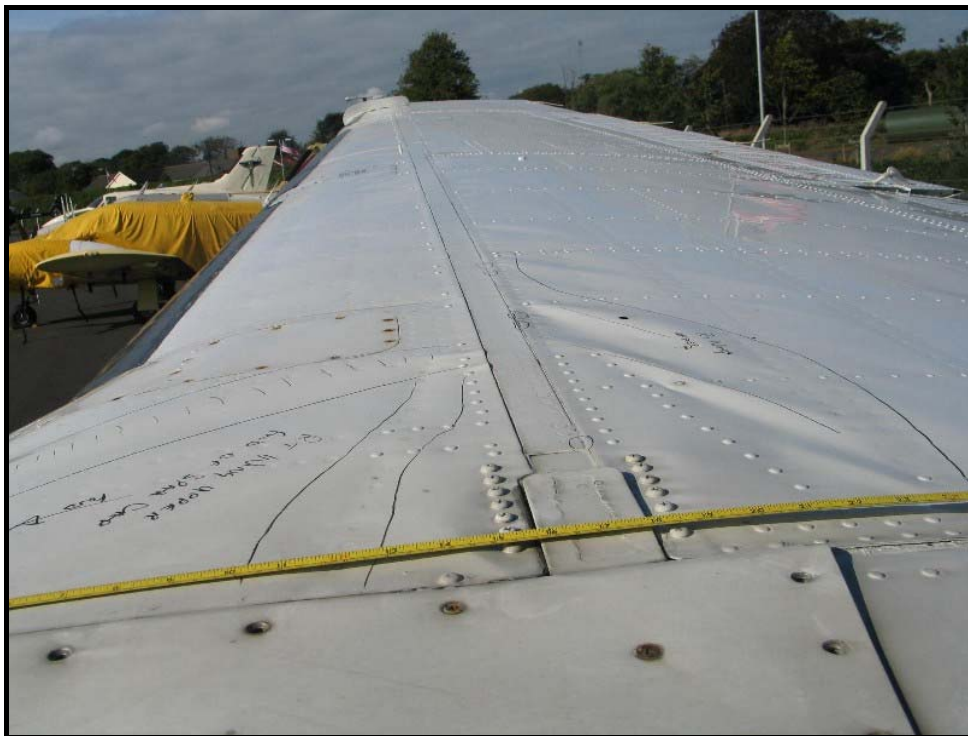
The upper skin ripples in **Photo 2** that extend outboard from the joint on both wings are symptomatic of gross over speed and occurs as aerodynamic forces push the wings up and aft. In this case drag would have been particularly high as the flaps were partially extended at the time of the occurrence. With a VFe of 174 knots and a possible speed reached between 280-300 kt this damage is not surprising as the exceedence could be in excess of 160% of VFE.

Photo 2
Upper skin rippling on starboard wing outside outer wing panel joint
