Air Accident Investigation Unit Ireland

FACTUAL REPORT

**ACCIDENT
IKARUS C42 FB, G-CEFA
Near Garristown, Co. Meath
20 April 2013**

AAIU Report No: 2013-012
 State File No: IRL00913035
 Report Format: Factual Report
 Published: 17/09/2013

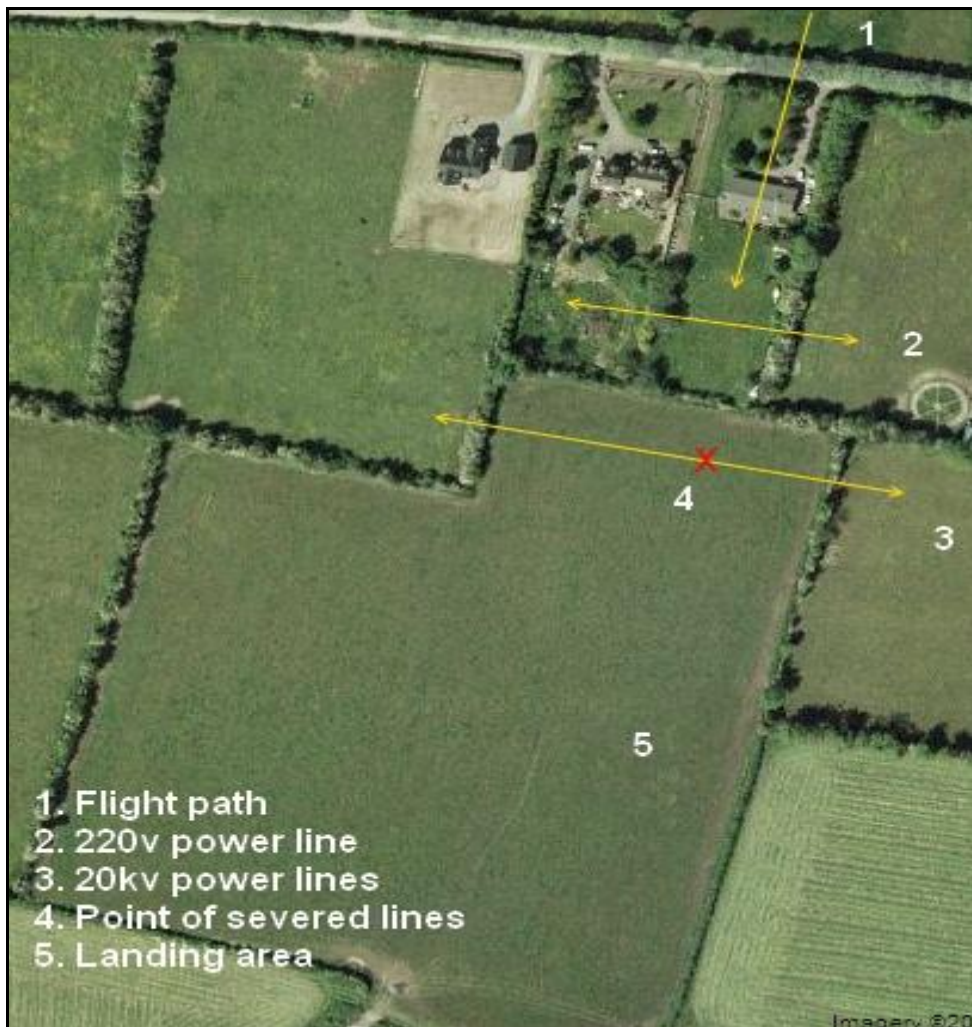
Graphic No. 1: Depiction of occurrence area

On arrival at the accident site, the house owner pointed out two separate sets of power lines to the IOC. The first set was a 220 V line running across his back garden at right angles to the approach path. The second set was located in an adjacent field at the end of his garden, parallel to the first set and at right angles to the approach path (Graphic No. 1).

Both lines of the second set were severed at the mid-point of the span of approximately 50 meters. The associated poles on either side of the span were embedded within the field boundary hedgerow.

The house owner told the IOC that he heard an aircraft fly very low over his house. In his opinion the aircraft first struck the power line in his garden, which *“bounced up and down for a significant period of time after the aircraft had left”*. The aircraft continued into the adjacent field and struck/severed a set of power lines; there was no flash or bang. The aircraft flew away, but as he was concerned for the safety of the pilot he decided to call in what he had seen.

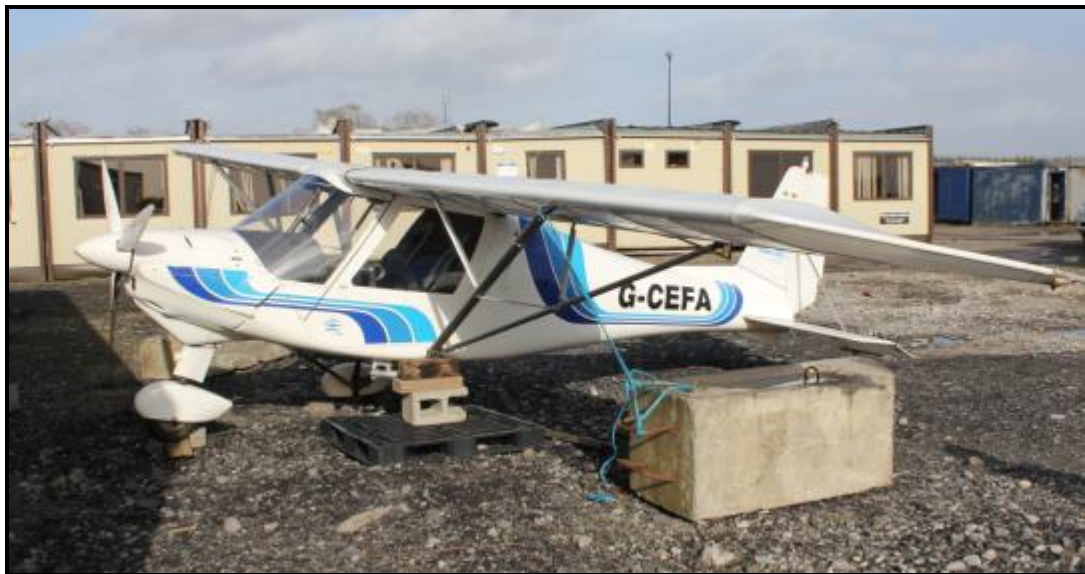
The aircraft was examined by an AAIU Engineering Inspector at Barstown airstrip some days after the occurrence. Apart from the removed port side main undercarriage assembly, there was no damage to the aircraft and no visible evidence was found that the aircraft had come in contact with power lines (**Photo No. 1**).

On examination of the removed port side main undercarriage assembly, evidence of power line contact was found on the forward supporting strut. It is considered by the Investigation that this strut was structurally weakened following contact with the power lines and subsequently failed in overload on landing at Barstown.

Photo No. 1: G-CEFA with port side main undercarriage assembly removed
