# **Air Accident Investigation Unit Ireland**

**SYNOPTIC REPORT**

**Robinson R44 Raven II, EI-DDA**

**18 August 2014**

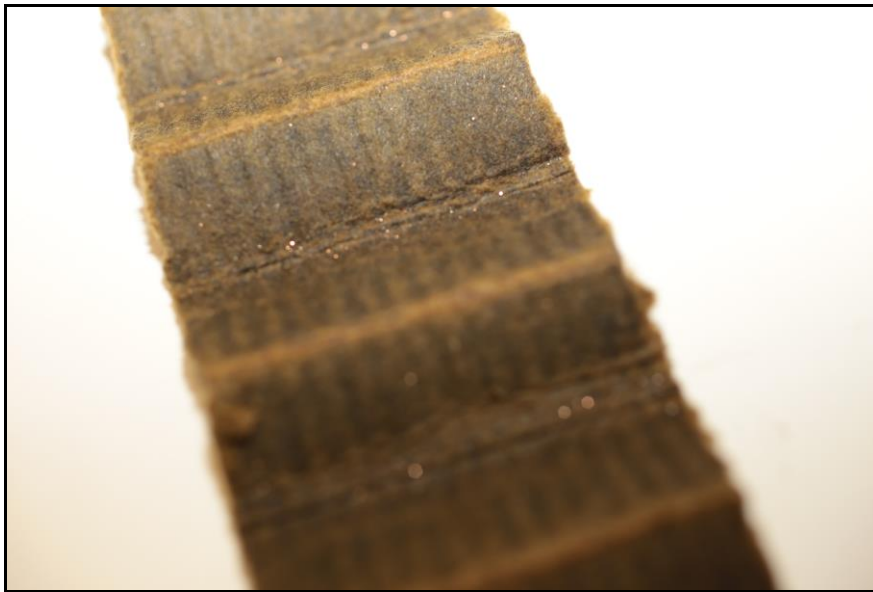
The engine oil filter element was examined and showed evidence of significant deposits of a material with a copper/phosphor bronze colour (**Photo No. 1**). Samples of the material were taken for metallurgical analysis.

**Photo No. 1:** Metallic deposits on oil filter element

The samples of the metal particles that were recovered from the oil filter, and a portion of the failed small end bushing were sent to a metallurgical facility for a comparison analysis. This analysis concluded that the particles were a good match for the bushing material.

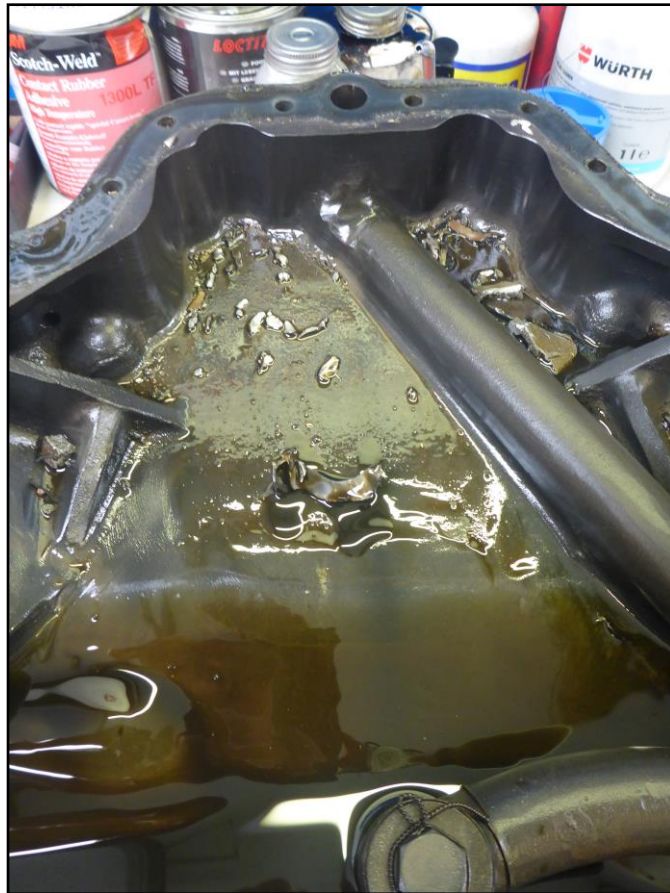
The oil sump was removed and a large amount of metallic debris was observed (**Photo No. 2**). The debris was examined and found to fit into three main categories:

**Photo No. 2:** Metallic debris deposited in the oil sump

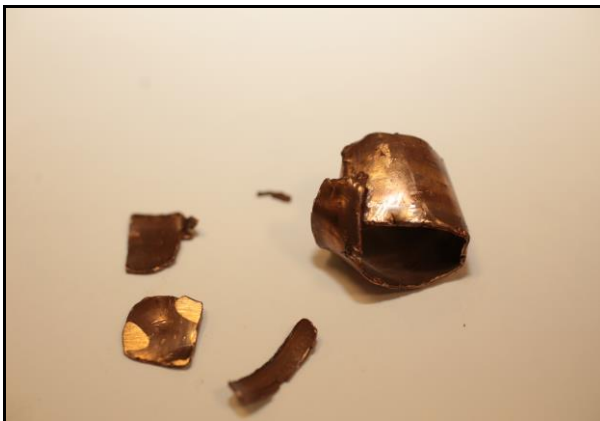
1. Large sections of phosphor bronze which appeared to be from a small end bushing.
2. Pieces of steel which appeared to be from sections of a connecting (con) rod and con rod small end (**Photo No. 3** and **Photo No. 4**).
3. There were also pieces of aluminium alloy suspected to be fragments of the crankcase.

**Photo No. 3:** Pieces of small end bushing retrieved from the oil sump

The overhaul facility reported that it appeared that the Number 3 small end bushing had deteriorated over an indeterminate period of time until an excessive amount of clearance was present between the Number 3 small end bushing and the Number 3 piston pin. This excessive clearance initiated the failure sequence during which the con rod was overloaded and failed. Subsequently, flailing of the failed con rod parts caused extensive secondary damage to the casings and the Number 3 and 4 cylinder skirts.

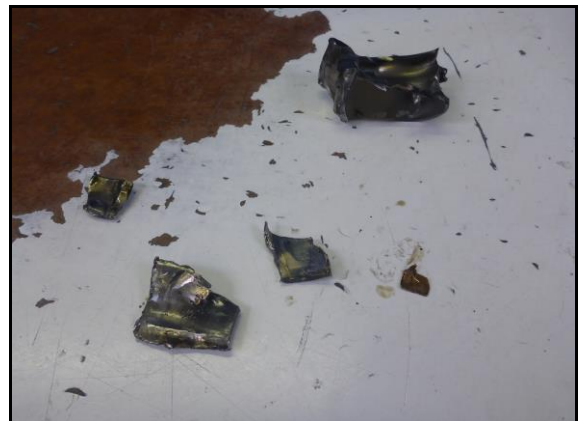
**Photo No. 4:** Pieces of the con rod/small end retrieved from the oil sump

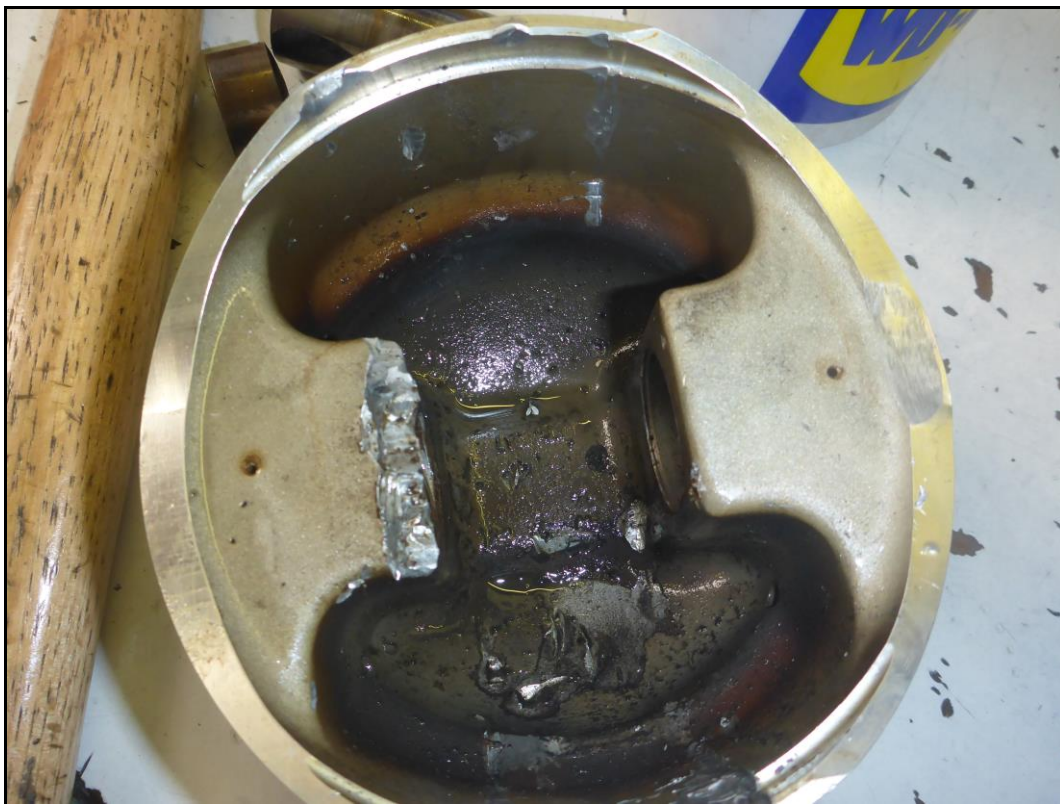
The Investigation was anxious to examine the Number 3 piston crown and the condition of the Number 3 cylinder valves. Con rods were removed from cylinders 1, 2, 4, 5 and 6 to facilitate crankcase splitting with the Number 3 cylinder still attached. The affected crankcase half was taken to an engineering workshop where the cylinder barrel was cut with an angle grinder, as close to the crankcase as possible. This allowed the piston to be removed and the piston and cylinder to be examined. No indications of overheating were found on the cylinder, piston crown, inlet or exhaust valves. The bottom of the piston exhibited impact damage consistent with the failure of the con rod (**Photo No. 5**).

**Photo No. 5:** Damage to the bottom of the Number 3 piston

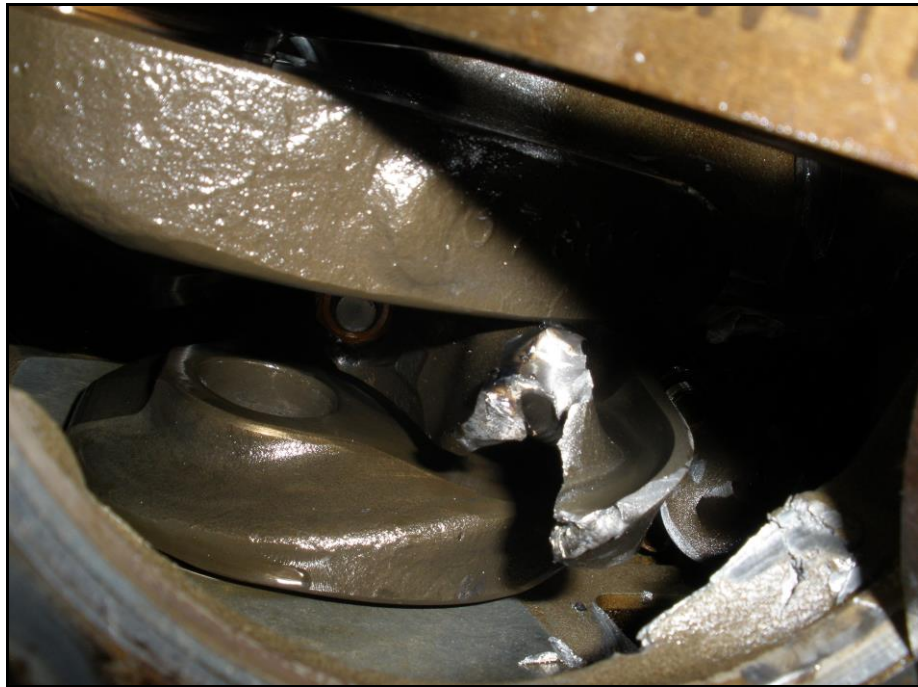
A small section of the Number 3 con rod remained attached to the crankshaft journal. This section was in contact with the crankshaft web and consequently was incapable of rotation (**Photo No. 6**).

**Photo No. 6:** Section of the Number 3 con rod, still attached to the crankshaft, in contact with web

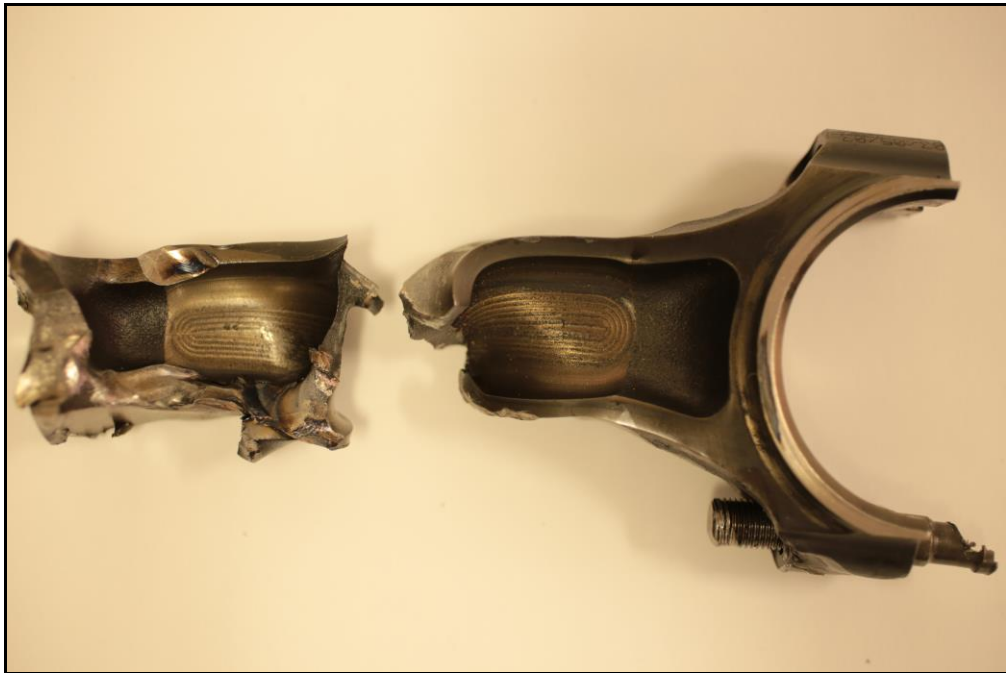
The section of the Number 3 con rod which was still attached to the crankshaft was removed and, for comparison, aligned with the section recovered from the engine sump (**Photo No. 7**).

**Photo No. 7:** Both sections of the failed con rod
