SERIOUS INCIDENT

Aircraft Type and Registration:	Boeing 737-8AS, EI-ENF
No & Type of Engines:	2 CFM 56-7B26 turbofan engines
Year of Manufacture:	2010 (Serial no: 35034)
Date & Time (UTC):	17 March 2022 at 0045 hrs
Location:	Manchester Airport
Type of Flight:	Commercial Air Transport (Passenger)
Persons on Board:	Crew - 6 Passengers - 167
Injuries:	Crew - None Passengers - None
Nature of Damage:	Fractured left main gear wheel hub
Commander's Licence:	Airline Transport Pilot's Licence
Commander's Age:	35 years
Commander's Flying Experience:	9,041 hours (of which 8,834 were on type) Last 90 days - 167 hours Last 28 days - 60 hours
Information Source:	Aircraft Accident Report Form submitted by the pilot and subsequent enquiries with the operator and wheel manufacturer

Synopsis

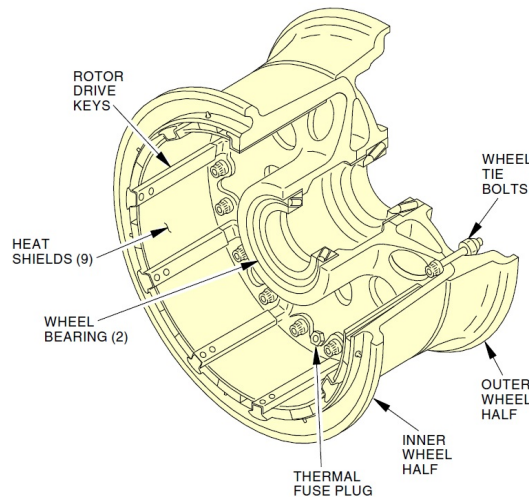
Figure 2

The Boeing 737-8AS is a single aisle commercial airline with a tricycle landing gear. Each main landing gear has two wheel assemblies attached to the landing gear axel. The wheels are made up of an inner and outer wheel half. Conical roller bearings located in the wheel half hubs carry the load from the wheel to the axel. Tie bolts hold the two halves together (Figure 2). The wheel brake pack is positioned within the inner wheel half.

Boeing 737-800 wheel assembly (reproduced with permission)
