Investigation Report

AX001-1-2/02
May 2004

Kind of occurrence: Accident
Date: 1 July 2002
Location: (near) Ueberlingen/Lake of
Constance/Germany
Type of aircraft: Transport Aircraft
Manufacturer/Model: 1. Boeing B757-200
2. Tupolev TU154M
Injuries to persons: 71 fatalities
Damage to aircraft: Both aircraft destroyed
Other damage: Damage to open field and forest
Source of Information: BFU Investigation

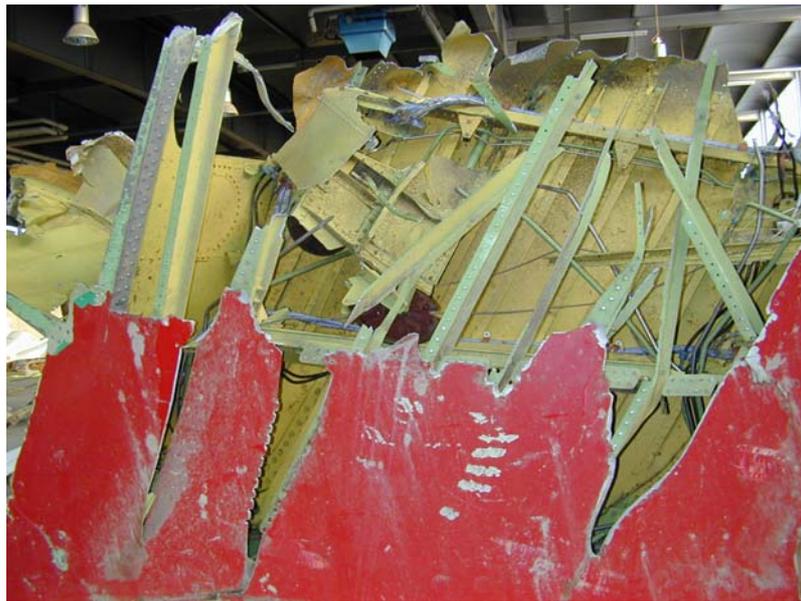
The top of the right side was bent to the rear left.

direction of flight

The top section of the vertical fin with a length of about 2,30 m was found south-east of the main wreckage at a distance of 4 to 5 km from the village of Altheim. The centre part of the vertical tail with a height of about 4 m and a length of about 5 m was not found.

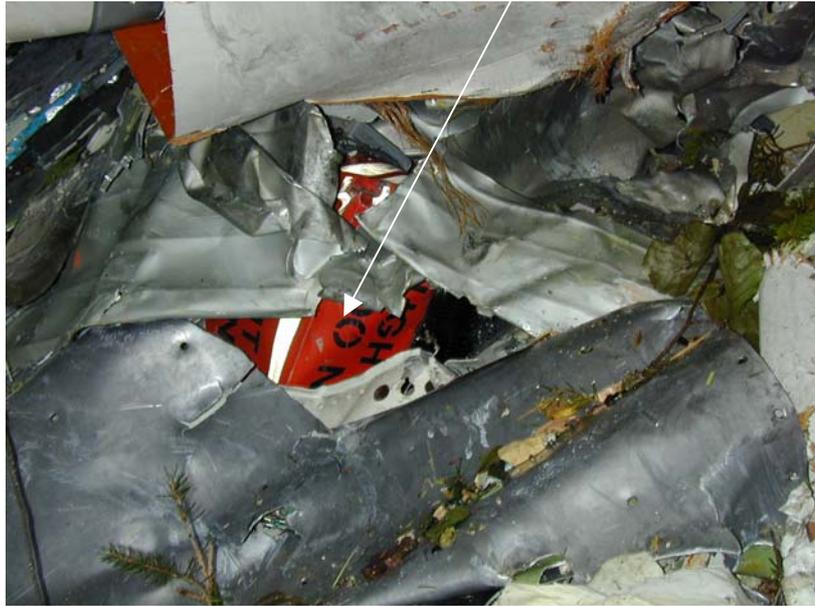
The FDR and the CVR were recovered from the aft part of the fuselage.

The ram air turbine (RAT) was found almost undamaged and without any traces of fire.
