Interim Report

| Location: | Near Lugano (Switzerland) |
| Manufacturer / Model: | Boeing / B737-800 |
| State File Number: | BFU FX003-12 |

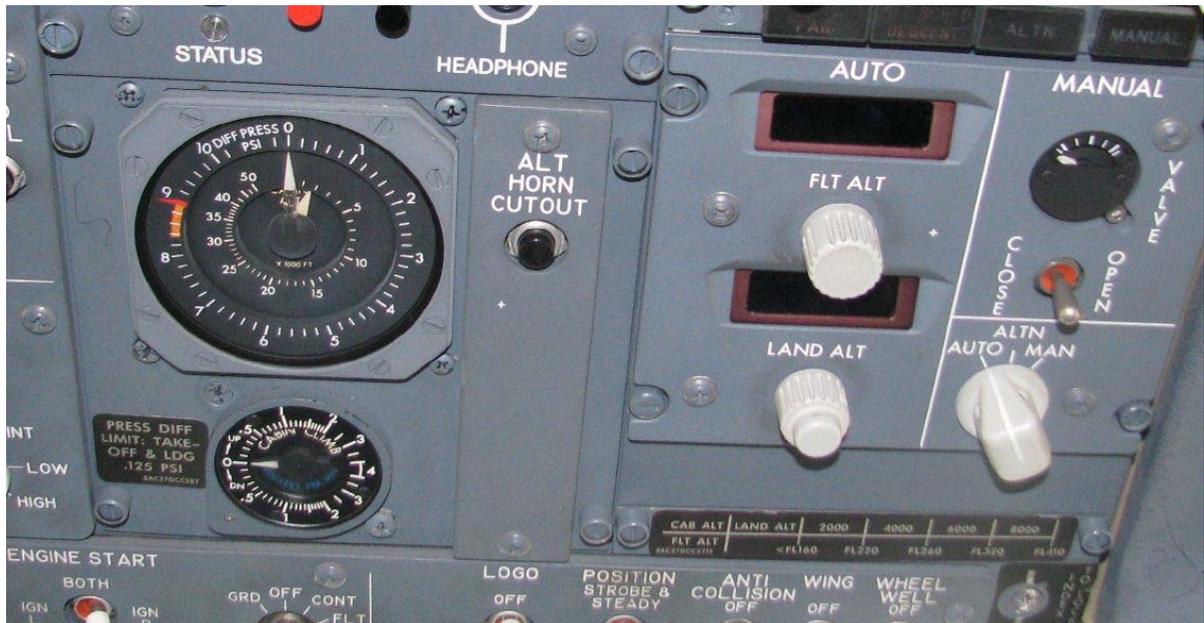
The operating and indication panel of the digital cabin pressure control system was part of the overhead panel in the cockpit. Indications for the cabin altitude and the differential pressure, the cabin rate of climb indicator (maximum 4,000 ft/min) and the outflow valve position indicator were installed.

Digital Cabin Pressure Control System
