## Report IN-010/2010

Incident occurred on 14 May  
2010, to aircraft Boeing 737-800,  
registration EI-DYX, operated  
by Ryanair during approach  
to Valencia Airport (LEVC), Spain

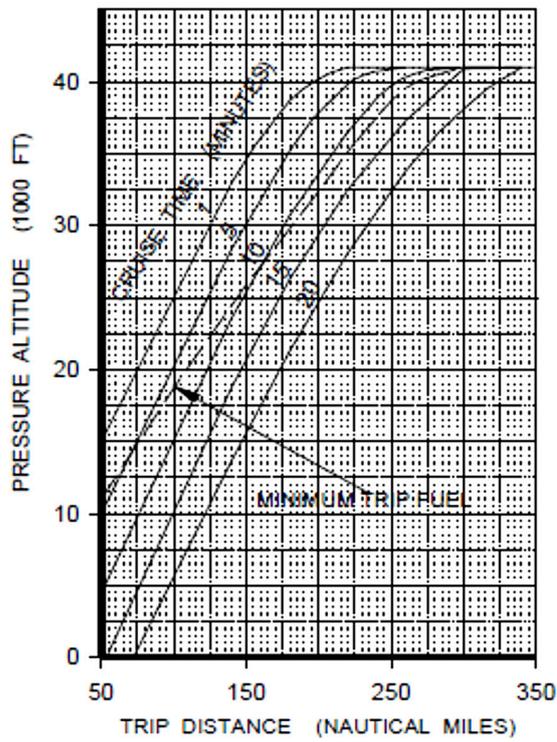
Short Trip Cruise Altitude

Boeing's Flight Planning and Performance Manual (FPPM) includes a graph for short distances that can be used to calculate fuel consumption for short-distance flights as a function of various parameters such as weight, altitude, wind and temperature. The graph also outputs the optimal, or lowest consumption, level (see figure). For a distance of 103 NM, the minimum fuel curve corresponds to an altitude of 18,000 ft.
