Technical report

IN-044/2020

Incident involving a Boeing 737-800 aircraft, registration EI-EBC, and a Beechcraft B200 aircraft, registration EC-MUP on 23 October 2020 at Málaga Airport

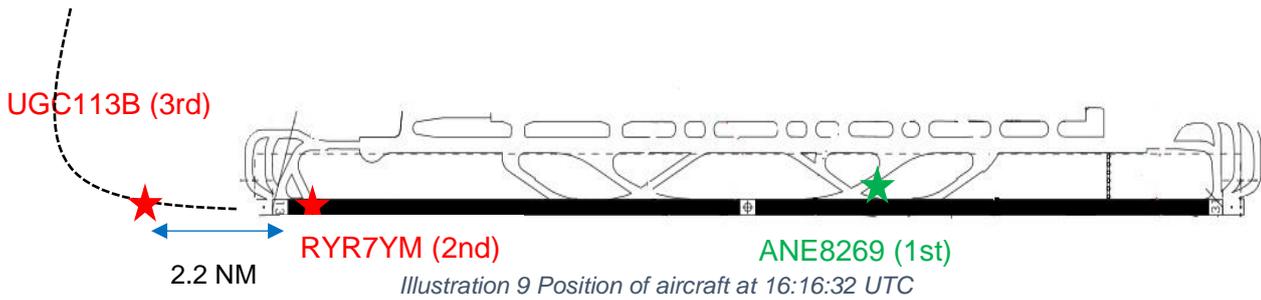
At 16:16:32 UTC, the trace shows aircraft RYR7YM aligned at the head of runway 13. The first aircraft in the sequence, ANE8269, is leaving the runway via the exit taxiway. The third aircraft in the sequence, UGC113B, is on short final at 2.2 NM from the threshold of the runway.

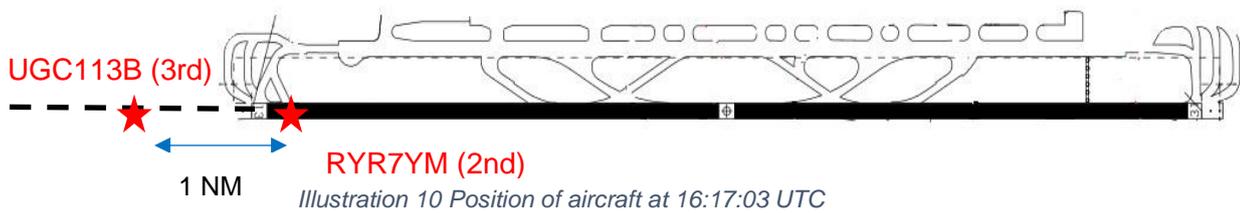
At 16:17:03 UTC, the trace shows aircraft RYR7YM initiating its take-off run at a speed of 20 kt. Aircraft UGC113B is on short final at 1 NM from the threshold of the runway, flying at a speed of 130 kt.

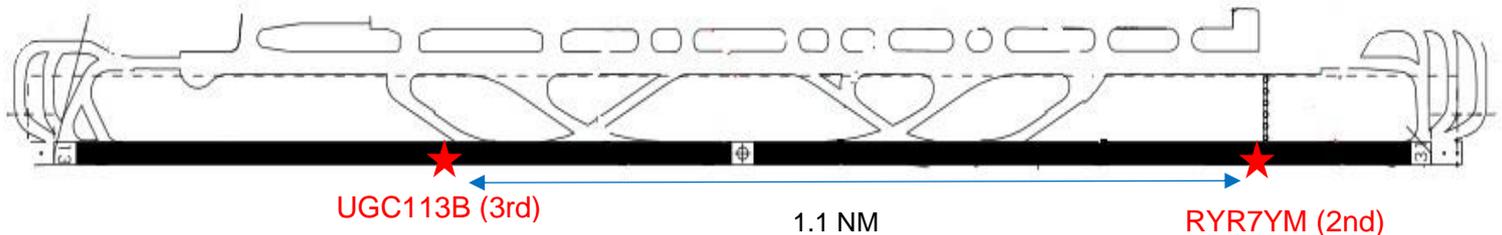
Illustration 13 Position of aircraft at 16:17:49 UTC

At 16:17:49 UTC, the trace shows aircraft RYR7YM climbing on take-off to 500 ft AMSL and aircraft UGC113B landing on the first third of the runway. At this point, the horizontal separation between the aircraft was 1.1 NM.

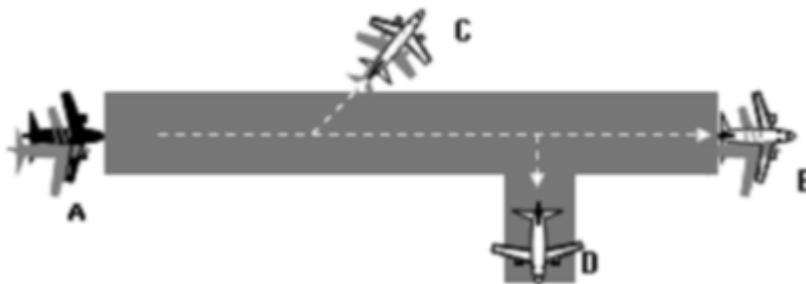
Illustration 23 Definition of free runway in the Air Traffic Regulations

The air traffic controller authorised the approaching aircraft to land when it was over the runway threshold, thereby allowing it to cross the threshold when the aircraft taking off was still on the runway initiating rotation, with no degree of assurance that regulatory separation could be maintained. The air traffic controller failed to anticipate the required separation between the aircraft.

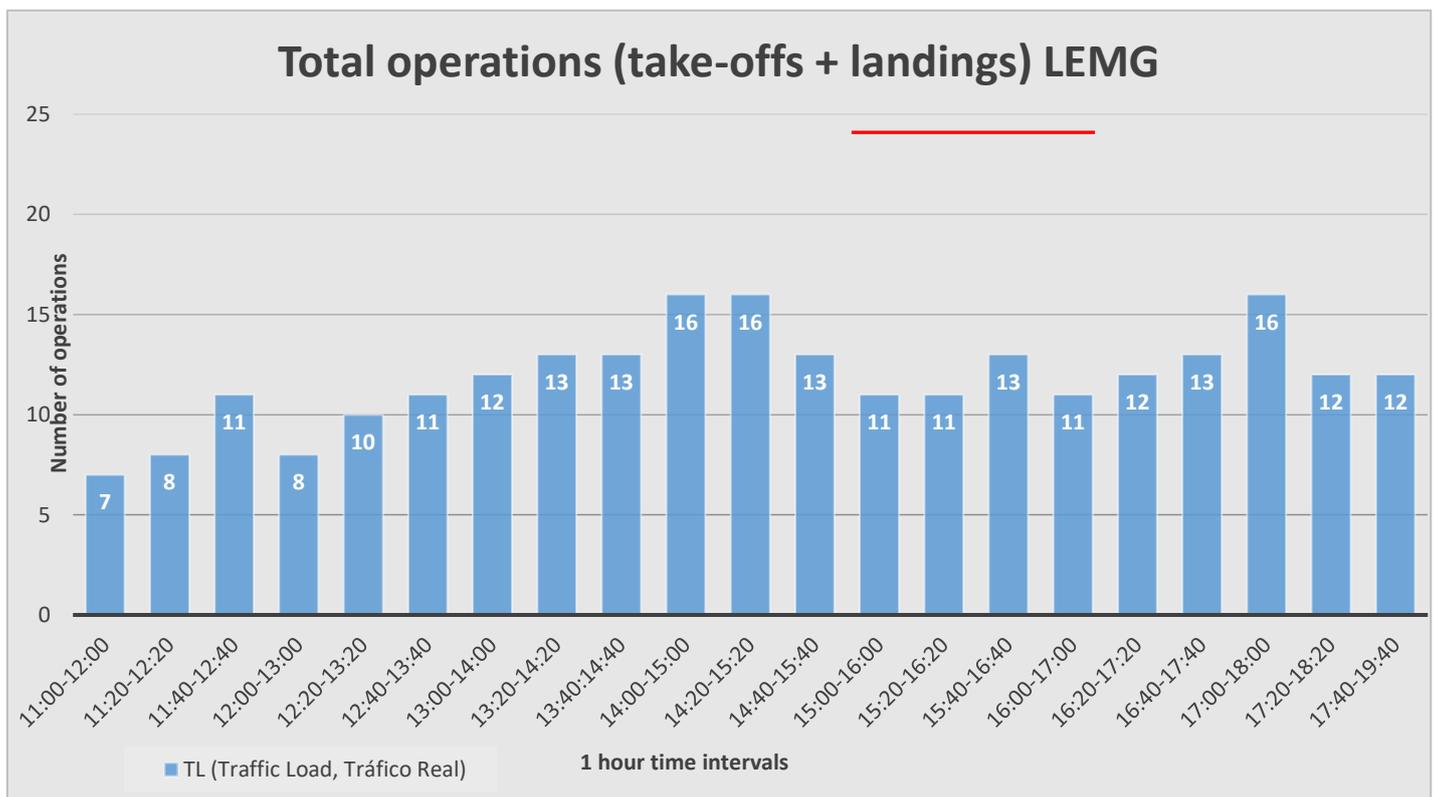
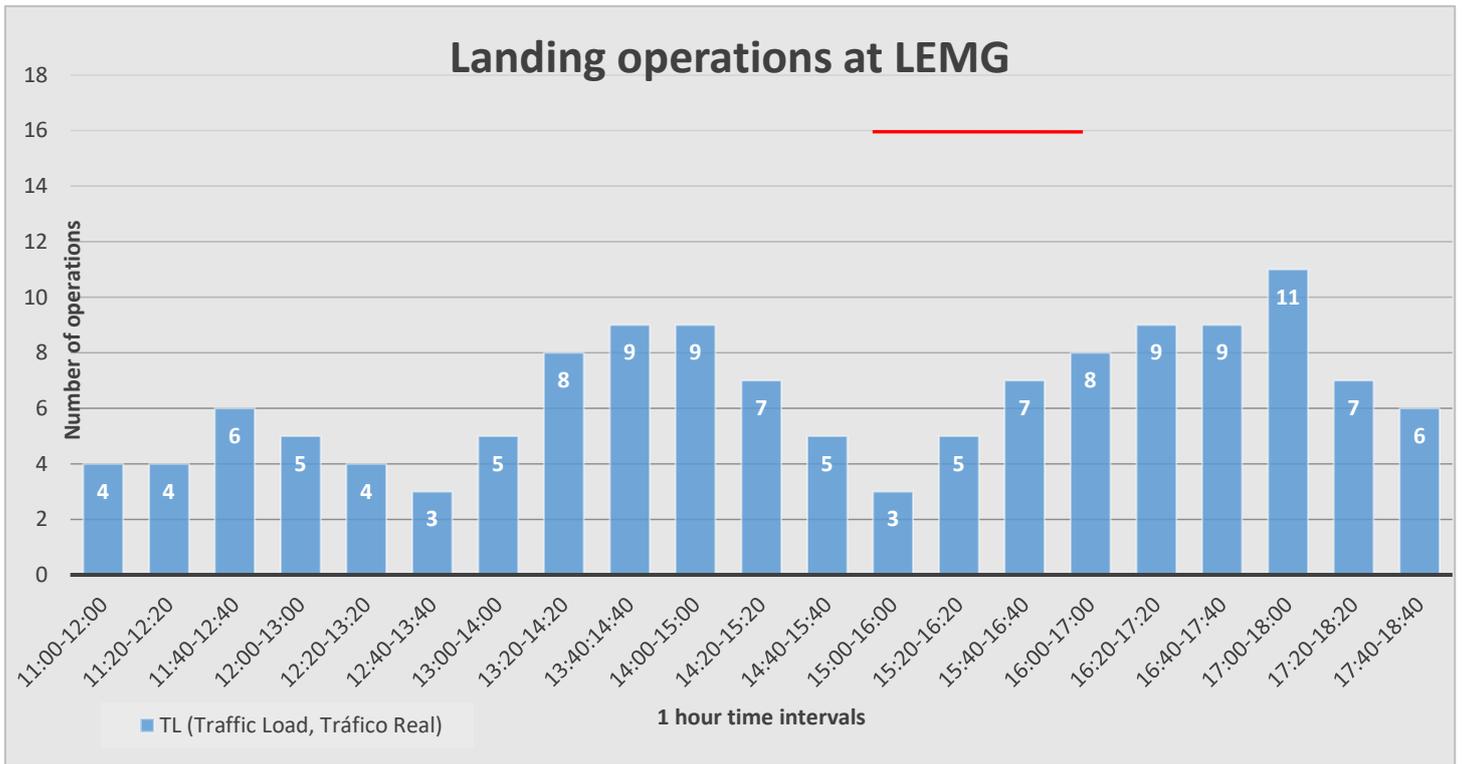
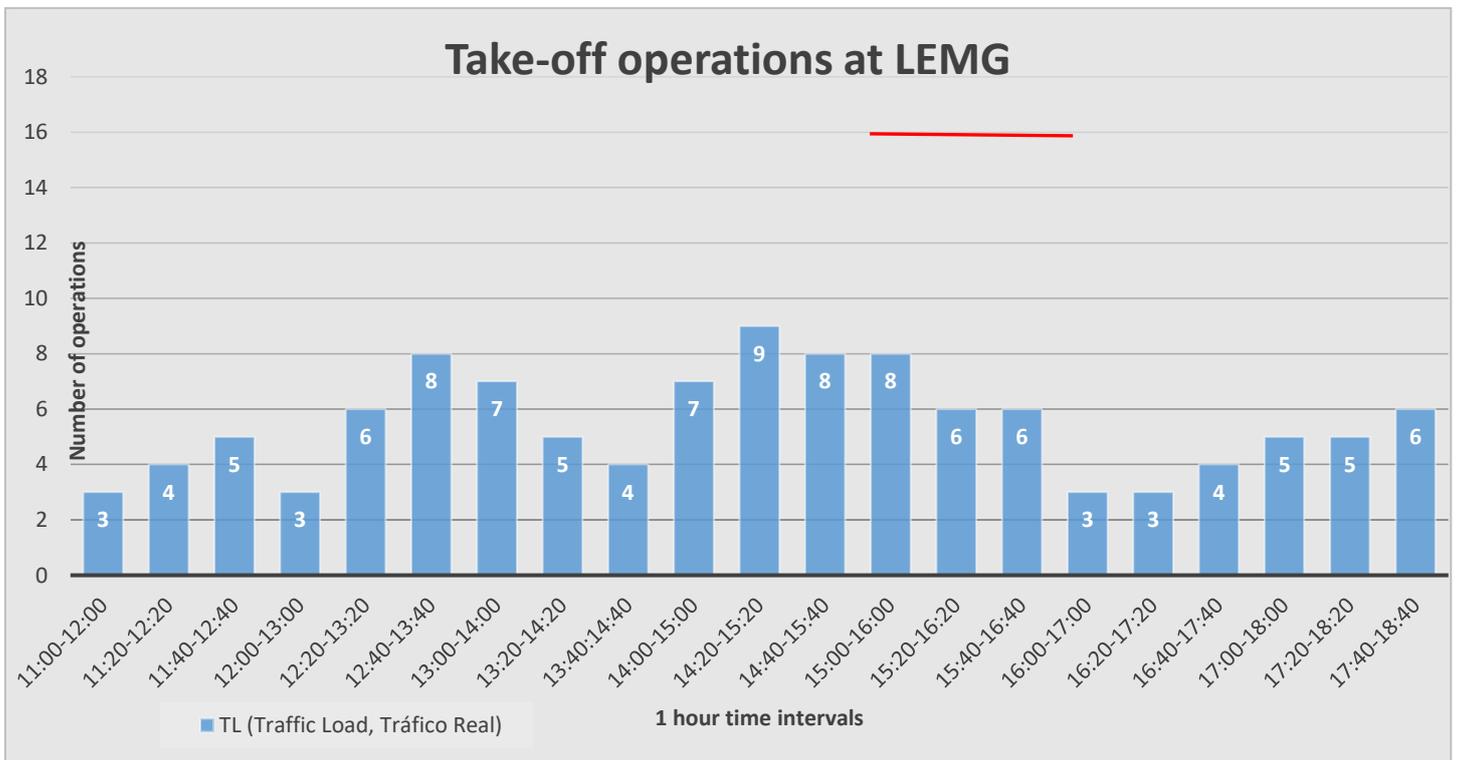
In the graphs, the red horizontal line represents the capacity limit in the time slots in which only 2 control positions were open. The following can be observed:

- At the time of the incident (16:15 UTC), the actual traffic, both in terms of take-offs, landings and total operations, did not exceed the capacity limit for two open tower control positions.
