AAIU Report No. 2000/012
AAIU File No. 2000/0025
Published 07 September 2000

Aircraft Type and Registration: HS. 748 Series 2A. G-BVOV

Date and Time (UTC): 28 April 2000 20.47 hours

Location: Dublin Airport

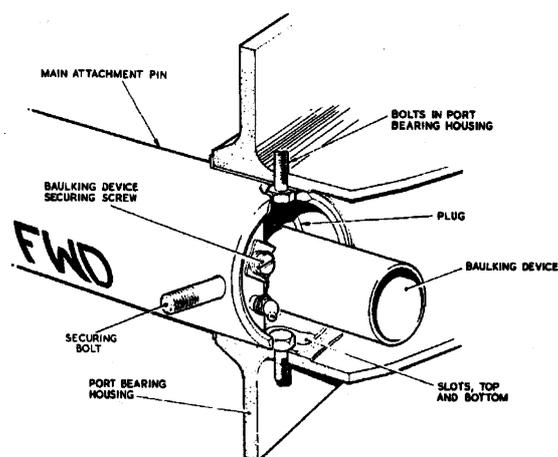
The nose strut of the BAe 748 is attached to the fuselage through a nose undercarriage attachment pin (*left*). This pin is inserted through an opening in the starboard side of the front fuselage. It is secured on the port side using a securing bolt, which secures the pin through holes in the port bushing housing. The port bushing is secured to the housing using two bolts. The attachment pin incorporates slots to facilitate the bolt heads. The pin also incorporates an internal greasing plug and the greasing

plug receives a baulking device incorporated by Mandatory Modification 4046 (S.B. 32/45). The baulking device, when fitted properly, should ensure that the holes in the attachment pin, port bearing housing and baulking device all line up in order to receive the securing bolt. In this way it would be impossible to insert the attachment pin and secure it to the bush housing using the slots intended to facilitate the bearing housing bolts. If, however, the baulking device is excluded, it is possible to fit the attachment pin at 90 degrees from its correct position and attempt to secure the pin with the securing bolt running through the attachment pin slots. In service the attachment pin would then work its way out of the housing. The starboard bearing housing would then take all forces transmitted through the nose leg, pulling the housing from its securing structure. (*see Fig.1 for complete breakdown of assembly*)

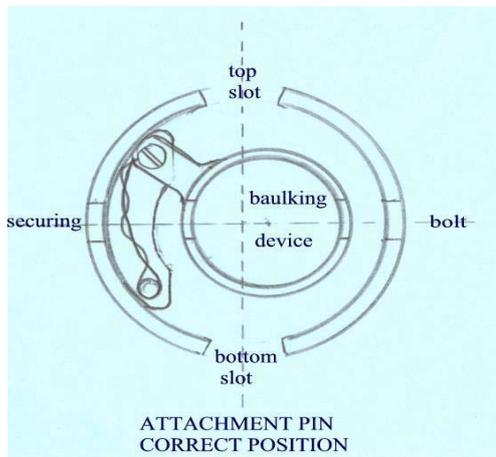
- (a) The attachment pin was found with the face marked "FWD"(forward) facing downwards. The holes in the pin were therefore in the vertical rather than in the horizontal.

- (b) If the pin had been fitted in this way the slots would have been in a position to receive the securing bolt.
- (c) The greasing plug was found moved in the attachment pin such that the hole in the plug could not line up with the hole in the pin.

- (f) There is a possibility that if the lug on the baulking device had broken off such that the device and the plug were no longer attached then the baulking device could be free to rotate during fitting.

- (g) As the slot diameter is greater than the securing bolt diameter there is a possibility that the holes in the baulking device and the slots in the pin would line up to receive the securing bolt.

- (h) The baulking device would then be secure but the pin, and with it the plug, would be free to migrate out of the port housing.

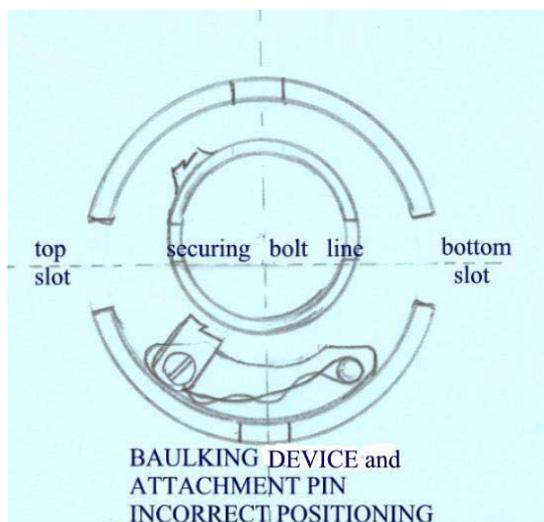
**Securing Bolt in
Baulking Device as
found by investigators**

Examination has shown that only the baulking device was secured by the bolt in the port housing. The attachment pin complete with greasing plug was free to migrate out of this housing. The securing bolt did not go through the hole in the greasing plug. It has to be concluded that the attachment pin was fitted with the slots horizontal and with the securing pin inserted through these slots.

The screw retaining the baulking device to the greasing plug was in place and secure. However, the lug had broken off the baulking device. If the lug was attached prior to fitting of the attachment pin with the letters FWD facing down as found, then it would have been impossible for the securing bolt to go through the baulking device. It has to be concluded therefore that the lug on the baulking device had broken off and remained with the plug prior to reassembly of the nose. The baulking device was therefore free to rotate in the greasing plug. It is conceivable that the securing bolt then passed through the baulking device and the slots in the attachment pin, allowing the attachment pin, complete with greasing plug, to migrate out of the port housing. If the strut, attachment pin, baulking device and greasing plug had been fitted in the way found prior to the nose gear removal, as stated, then it is unlikely to have remained in place during five years of operation.
