Air Accident Investigation Unit Ireland

SYNOPTIC REPORT

**Cessna FR172K Hawk XP, EI-EZU
Near Killimordaly, Co. Galway**

11 July 2020

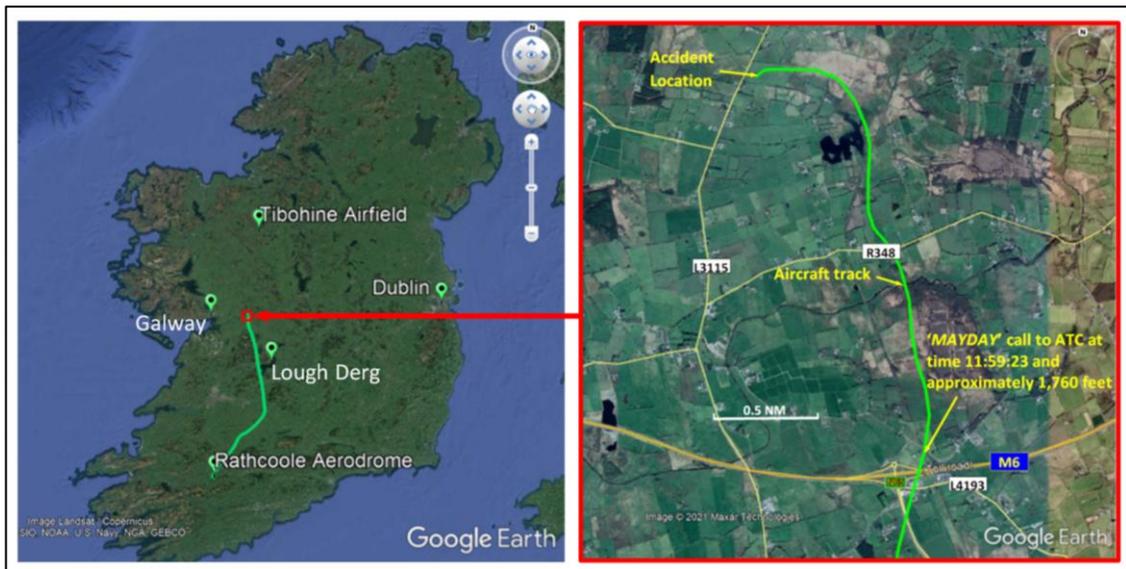
Figure No. 1: Aircraft track showing location of MAYDAY call and accident site

The aircraft took-off from Runway (RWY) 27 at EIRT at approximately 11.15 hrs on 11 July 2020. The purpose of the flight was to attend a 'fly-in' at Tibohine Airfield, Co. Roscommon. The aircraft's track after take-off, which was obtained from the Pilot's portable GPS⁵ navigation unit (Satnav), is shown in **Figure No. 1**. During the early part of the flight, Shannon ATC instructed the aircraft to route east of the controlled airspace surrounding Shannon Airport and the Pilot therefore turned the aircraft towards the north-east. The aircraft continued in this direction for approximately 20 minutes, before taking up a generally northerly track towards the destination airfield. At approximately 11.46 hrs, the Pilot contacted Shannon ATC to advise that the aircraft was passing Lough Derg (Co. Clare). Later, at approximately 11.58 hrs, the Pilot advised ATC that the aircraft was just passing Loughrea (Co. Galway).

Data obtained from the Satnav indicated that the aircraft's elevation and airspeed decreased at this stage. Just over one minute later, at an elevation of approximately 1,760 feet (ft), the Pilot contacted Shannon ATC, reported the aircraft registration and stated: 'MAYDAY, MAYDAY, looks like I'm having an engine failure, serious loss of oil pressure, I'm going to have to make an emergency landing'. ATC acknowledged the transmission and advised that there was no known air traffic in the vicinity. No further transmissions from the aircraft were received by ATC, despite several attempts to contact the aircraft.

After the MAYDAY call, the aircraft descended in a north-north westerly direction for approximately 1.5 nautical miles (NM), before commencing a turn towards the west as it approached an agricultural field near Killimordaly, Co. Galway. The aircraft contacted the ground hard during the attempted forced landing. When the aircraft came to rest, it was on a magnetic heading of 114° (i.e. back towards the direction it had approached from). The impact occurred approximately two minutes after the MAYDAY call was made. The aircraft sustained substantial damage in the impact sequence (**Photo No. 1**). There was no fire.

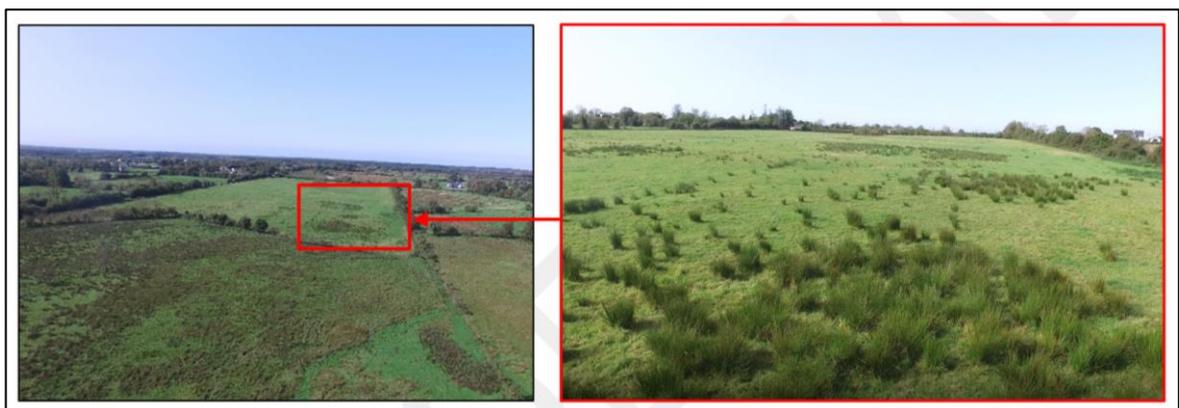
Figure No. 2: Aerial view of field as per final approach and when closer to the ground

On a date subsequent to the accident, the Investigation conducted an aerial survey of the site using a Remotely Piloted Aircraft System (RPAS). The purpose of the RPAS flight was to replicate the aircraft's approach path to the field, based on the elevation and position data obtained from the Satnav (**Section 1.13**). Still images extracted from the RPAS video recordings at two different stages of the approach are shown in **Figure No. 2**. The left-hand image in the Figure shows the aerial view of the field looking west (as per the subject aircraft's final approach); the right-hand image in the Figure shows the view of the surface conditions at the field's eastern end when closer to the ground.

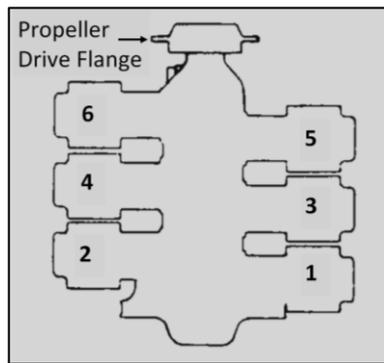
Figure No. 3: Engine cylinder numbering (viewed from above)

The aircraft was powered by a Teledyne Continental Motors (TCM) IO-360-KB fuel-injected, air-cooled, horizontally opposed, six-cylinder engine (Serial Number 235960R). The engine cylinders are numbered as shown in **Figure No. 3**. A breather pipe is connected to the engine crankcase to permit venting of any gases that have leaked past the piston rings ('*blow-by*'). The breather pipe exits through the lower engine cowling. The engine was fitted with a three-blade MTV-12, variable pitch propeller. The propeller blades were manufactured from wood.

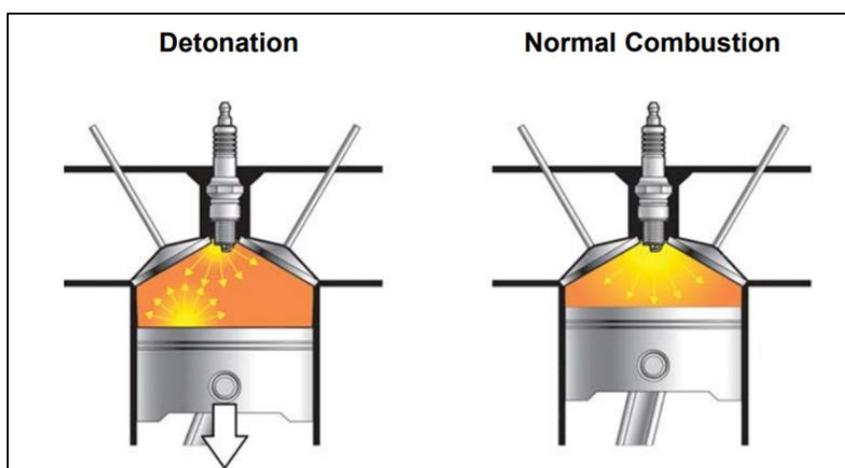
Figure No. 5: Detonation versus normal combustion (FAA)

Detonation is defined in the FAA's Advisory Circular 33.47-1 (dated 27 June 1988) as '*the spontaneous combustion of an unburned charge [fuel-air mixture] which occurs ahead of the flame front after normal ignition*' (**Figure No. 5**). The increase in pressure and temperature as a result of the normal, spark-induced combustion precipitates detonation. Both flame fronts meet, causing a rapid increase in pressure. According to a presentation produced by the FAA's Safety Team, '*mild detonation may increase engine wear, though some engines can operate with mild detonation. However, severe detonation can cause engine failure in minutes*'.

As shown in **Figure No. 5**, detonation occurs ahead of the normal (spark-induced) flame front and usually initiates at the extremities of the combustion chamber. It can cause rapidly rising temperatures at the piston edges, which, along with the piston ring lands, can be damaged as a result. Once this occurs, the damaged piston edge is exposed to severe heat and pressure which can cause a hole to be burned through the edge of the piston. Once the integrity of the piston is compromised, pressure from compression and combustion will cause the pressure within the crankcase to increase and could result in the engine's lubricating oil being ejected through the engine breather.

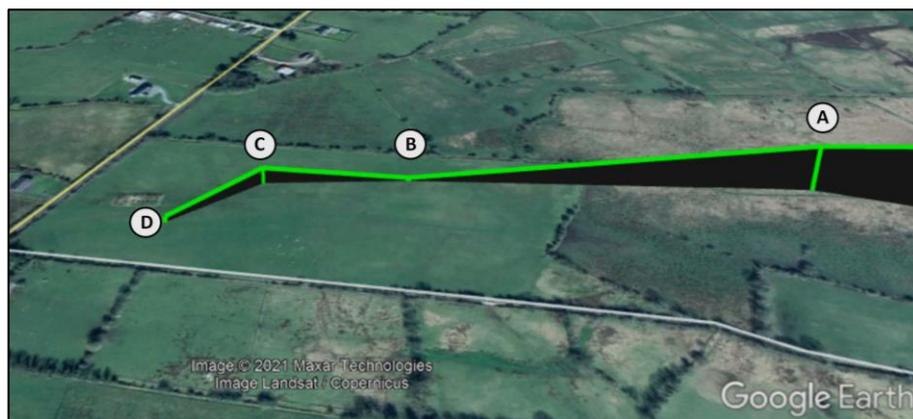
Figure No. 6: Final stages of flight as recorded by on board Satnav unit

According to the Satnav, in the final stages of the flight, the aircraft approached the field from the east (**Figure No. 6**). The Pilot informed the Investigation that this was because he was aware of the wind direction. At time 12:01:20, the Satnav recorded that the aircraft was approximately 200 m from the eastern perimeter of the field and was at an elevation of 310 ft (94 m) (**Point A, Figure No. 6**). The ground speed recorded was 71 kts (the ground elevation at this location was approximately 173 ft).

The next data point recorded (**Point B, Figure No. 6**) was at time 12:01:29, when the aircraft was above the field and had travelled over approximately one third of the length of the field; the Satnav recorded the aircraft's elevation at this point as 202 ft (62 m) and the ground speed as 58 kts (the ground elevation at this location was 190 ft). The next data point recorded (**Point C, Figure No. 6**) was at time 12:01:33 and was approximately 120 m from the previous data point, when according to the data, the aircraft had turned to the left by approximately 5°; an aircraft elevation of approximately 248 ft (76 m) and a ground speed of 36 kts were recorded at this point (the ground elevation at this point was 193 ft).

The final data point recorded (**Point D, Figure No. 6**) was at time 12:01:38. It was approximately 90 m from the previous data point and 40° to the left (south-west) of it. The Satnav recorded the aircraft's elevation at this point as 220 ft. The field elevation at this location is 197 ft (60 m). The aircraft wreckage came to rest approximately 10 m to the south-west of the final point recorded.
