Air Accident Investigation Unit Ireland

SYNOPTIC REPORT

**SERIOUS INCIDENT
BOEING 737-800, EI-DHI
Riga Airport, Latvia
7 January 2012**

AAIU Report No: 2013-017
State File No: IRL00912007
Report Format: Synoptic Report
Published: 19 December 2013

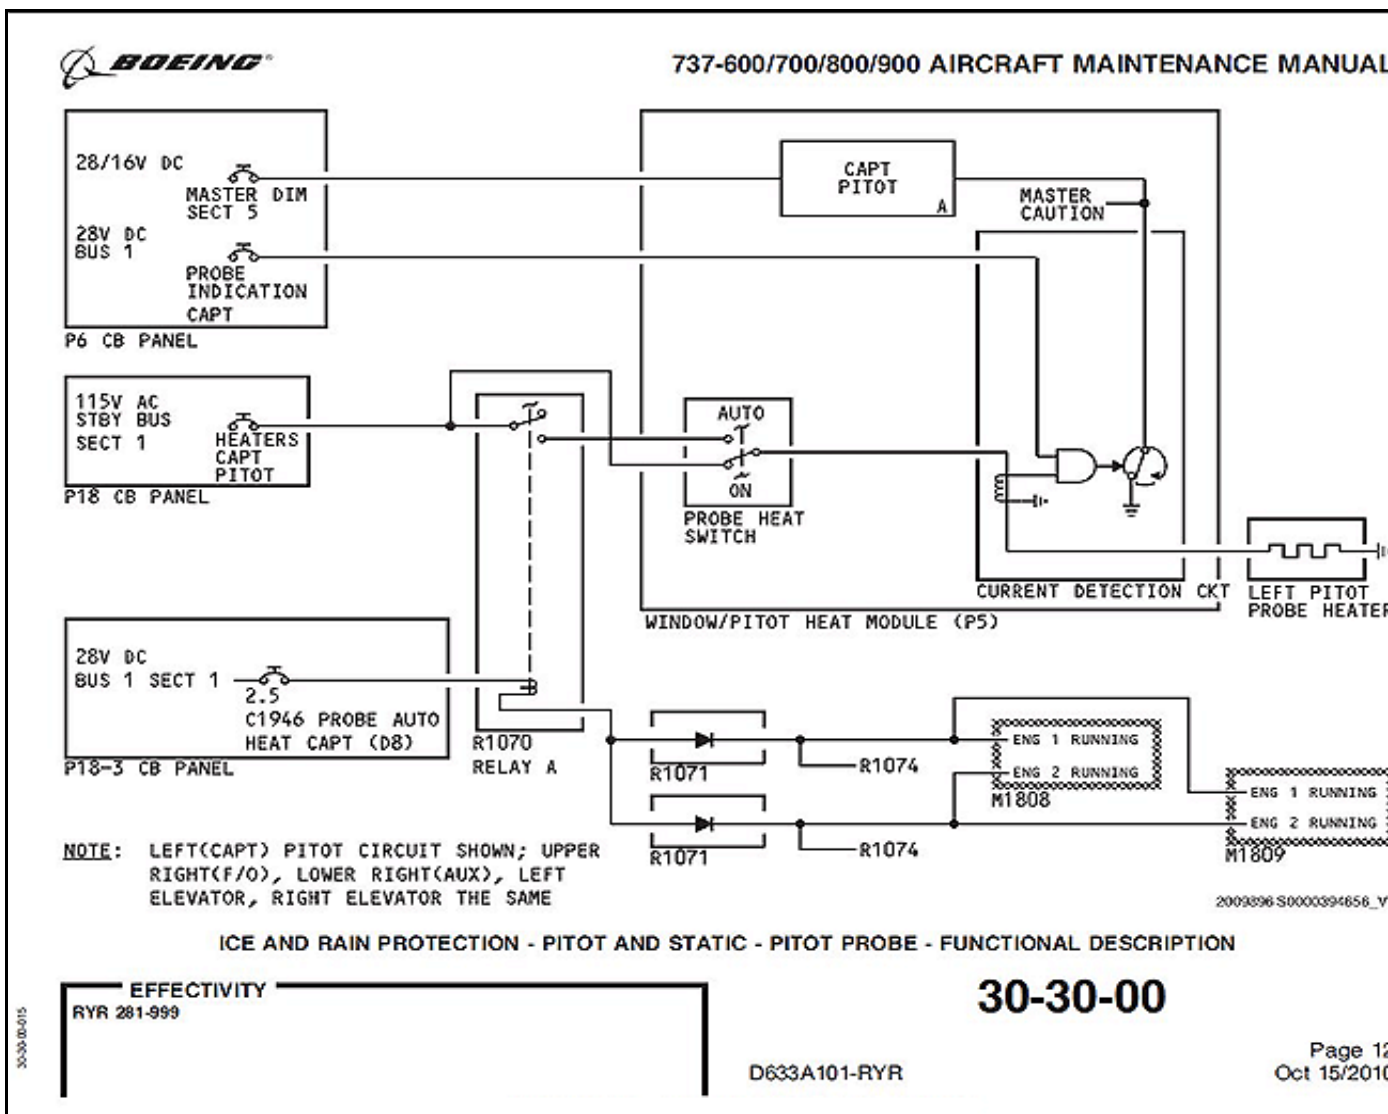
Pitot Probe Electrical Schematic

Subsequent maintenance action found that, although the pitot heater on the F/O's side had failed due to a short circuit, the pitot heater failure warning had not activated because the design of the warning system may not detect failures of this nature.
