# **Air Accident Investigation Unit Ireland**

**FACTUAL REPORT**

**Boeing 737-8AS, EI-EKB**

**En route Krakow - Edinburgh**

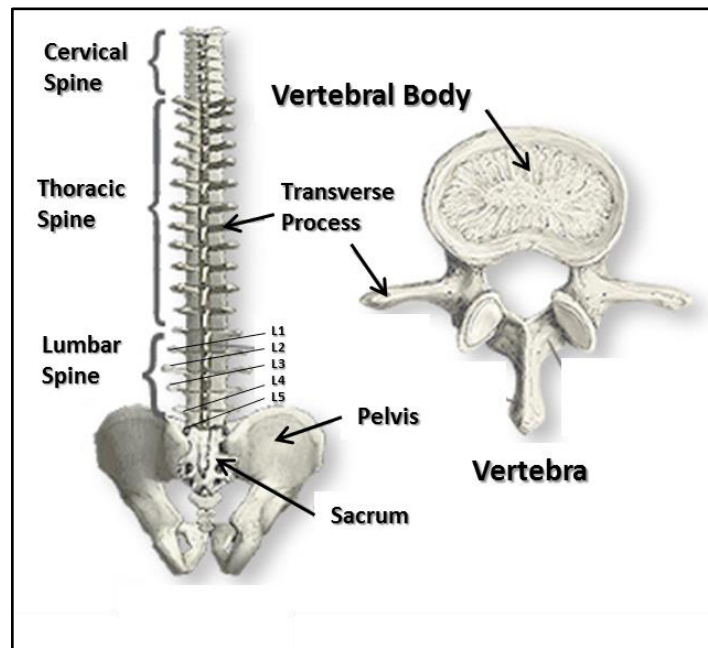
**Figure No. 1:** Spinal Column (*helpyourback.org*)

The AME stated that the spine is divided into the cervical, thoracic and lumbar regions (**Figure No. 1**). The vertebrae are then named by attaching a prefix based on the location of the bone; 'C' for cervical vertebrae, 'T' for thoracic vertebrae and 'L' for lumbar vertebrae. There are five lumbar vertebrae, named L1 – L5 respectively. The L1 vertebra is the first lumbar vertebra below the thoracic region.

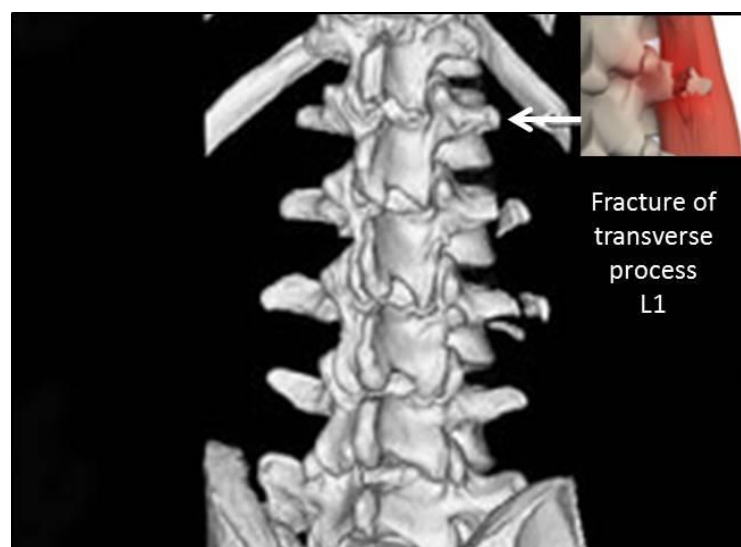
**Figure No. 2:** Lumbar Transverse Process Fracture (*mddirect.org*)

The CCM was diagnosed with a *"fracture of transverse process of the right vertebra L1"*. The Investigation sought general medical information from an aeromedical examiner (AME) regarding such an injury. The Investigation did not access the CCM's personal medical information.

A transverse process fracture is a rare injury. It can result from a direct impact to the process, although this is unusual due to the amount of surrounding muscle tissue. It can also result from a side bending or twisting motion. It requires a lot of force to cause this fracture. Due to their proximity to the transverse process, other muscles or organs such as the lungs, liver, kidney or spleen can be injured at the time of the fracture resulting in internal bleeding (**Figure No. 2**). The most common causes of a fracture of the transverse process are due to extreme rotation or lateral bending during a significant fall, a vehicular accident or recreational and sporting activities. This fracture does not normally affect the stability of the spine. The AME informed the Investigation that a patient with a fracture of the transverse process will have severe pain even if the actual break is small or limited and there is no injury to nearby bones, organs, or the spinal cord.
