# Air Accident Investigation Unit Ireland

FORMAL REPORT

Cessna T182T, N247P  
Blackstairs Mt., Co. Carlow, Ireland

24 May 2015

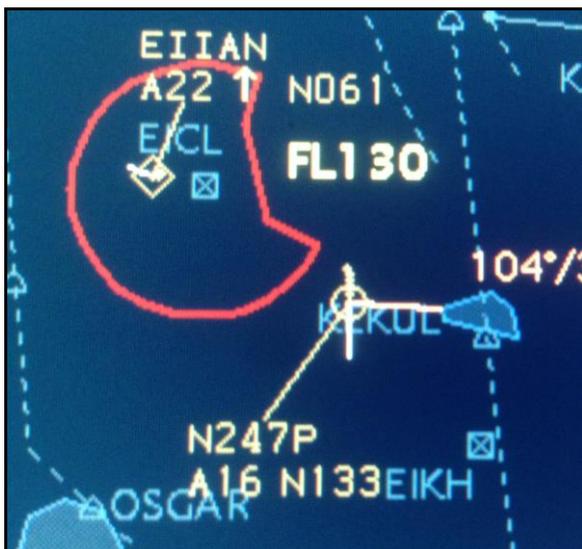
The Investigation reviewed a replay of the radar data obtained from Shannon ATCC. The aircraft first appeared on ATC radar at 09.00 hrs passing an indicated altitude of 900 ft in a climb. The radar replay shows that the aircraft levelled at an altitude of approximately 1,500 ft and tracked in a southerly direction routing abeam EICL where parachuting activity was taking place. The parachuting zone is represented by a red boundary line (**Photo No. 10**).

**Photo No. 10:** Radar image of N247P routing south abeam parachuting zone

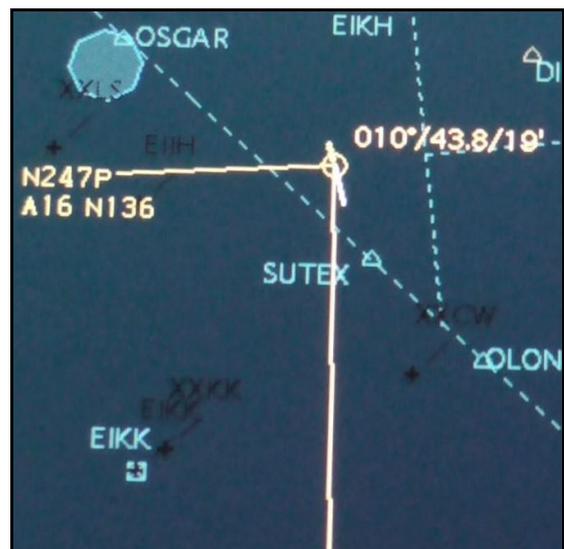
Approaching Athy, the aircraft turned left in the direction of ILAS Field and proceeded south of Carlow Town. Radar contact with the aircraft was lost, due to terrain masking at 09.20:06 hrs at a position 43 NM north of Waterford Airport. **Photo No. 11** shows the last radar return just prior to radar masking.

**Photo No. 11:** Radar image at 09.20:06 hrs prior to terrain masking

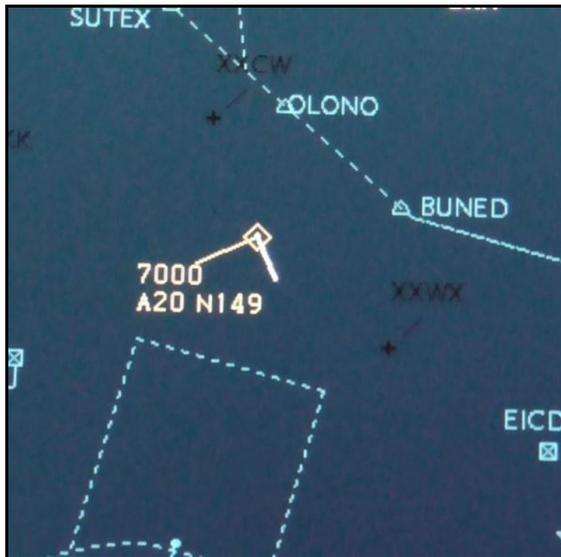
During the period of terrain masking, data from the portable Garmin 296 shows a shallow climb was commenced at 09.25:07 hrs. At 09.28:26 hrs, the aircraft reappeared on radar on the same track towards ILAS Field passing an altitude of 2,000 ft in a shallow climb at a groundspeed of 149 kts (**Photo No. 12**). The return shows the transponder code of 7000 which was immediately replaced by the aircraft registration once the Mode S radar head identified the aircraft. The final radar returns showed the aircraft at an altitude of 2,300 ft, 'A23' in **Photo No. 13**.

**Photo No. 12:** Radar image at 09.28:26 hrs when the radar return was re-established

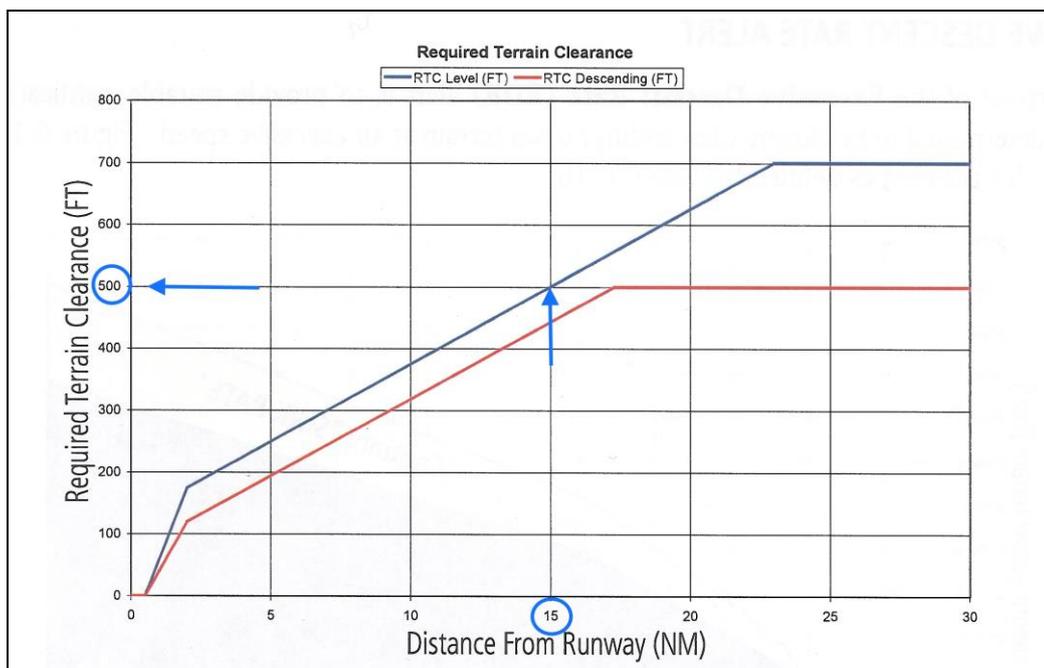
Acknowledging that the system should not be used for primary terrain avoidance, the Investigation considered, for completeness, how the minimum terrain clearance threshold varies with the distance to destination. At the point of impact, the aircraft was approximately 15 NM from its destination at ILAS Field. With ILAS Field entered as the destination runway, the FLTA Alert minimum terrain clearance value reduces (with the aircraft in level flight) from 700 ft to 500 ft as referenced by the dark blue line in **Figure No. 5**.

**Figure No. 5:** Reduced FLTA Alert, Minimum Terrain and Obstacle Clearance Values with aircraft 15 NM from destination runway)
