# **Air Accident Investigation Unit Ireland**

**SYNOPTIC REPORT**

**Westland Gazelle HT Mk.3 (SA 341), G-BXTH  
Abbeyshrule, Co. Longford, Ireland**

**15 July 2015**

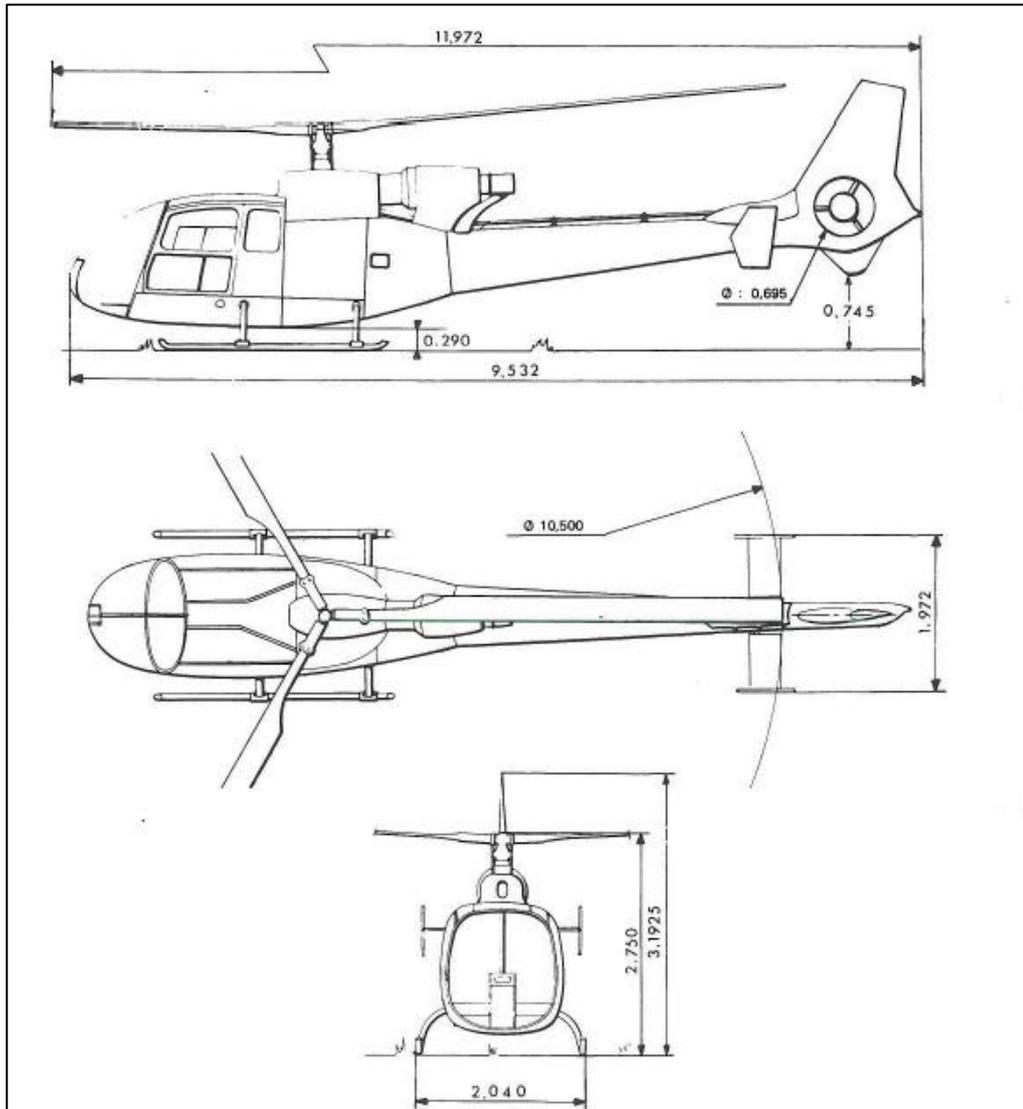
**Figure No. 1**, as provided by Airbus Helicopters, contains the principal dimensions of the helicopter. The overall length is 11.972 m and the main rotor diameter is 10.5 m.

**Figure No. 1:** Principal dimensions of Gazelle SA 341 (Courtesy of Airbus Helicopters)
