Air Accident Investigation Unit Ireland

PRELIMINARY REPORT

**Sikorsky S-92A, EI-ICR
Black Rock, Co. Mayo, Ireland**

14 March 2017

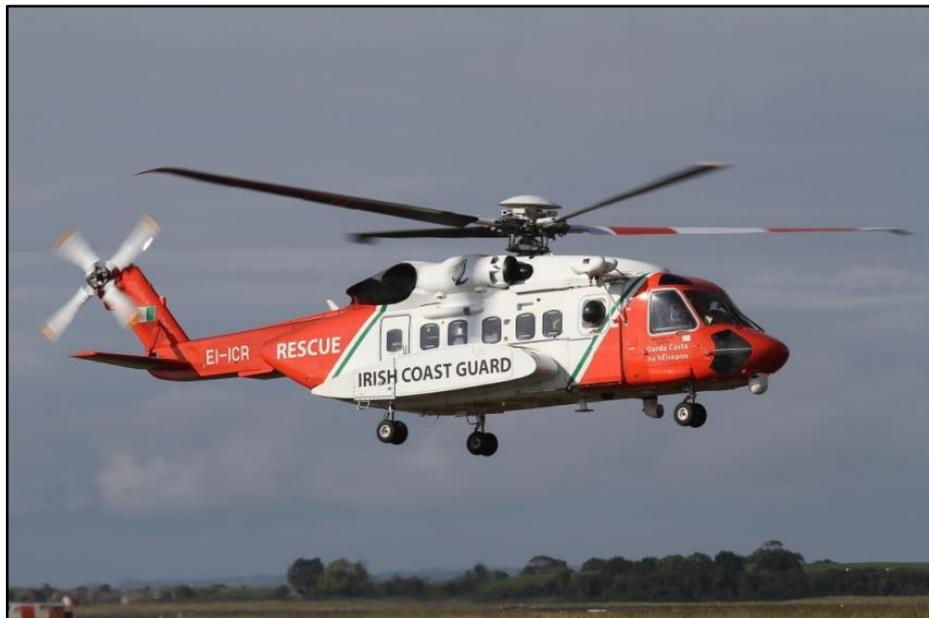
EI-ICR (**Photo No.1**), a Sikorsky S-92A helicopter, was manufactured in 2007. It was first registered in Ireland in 2013. Its Certificate of Airworthiness was issued by the IAA on 14 June 2013. The associated Airworthiness Renewal Certificate (ARC) was issued on 8 November 2016 and was valid until 7 November 2017. It was one of a fleet of five S-92A helicopters in use by the Operator. The helicopter had operated for a total time of 4,851 hours approximately from the date of manufacture until the occurrence date.

Photo No. 1: EI-ICR, Sikorsky S-92A (*Tom Moloney*)

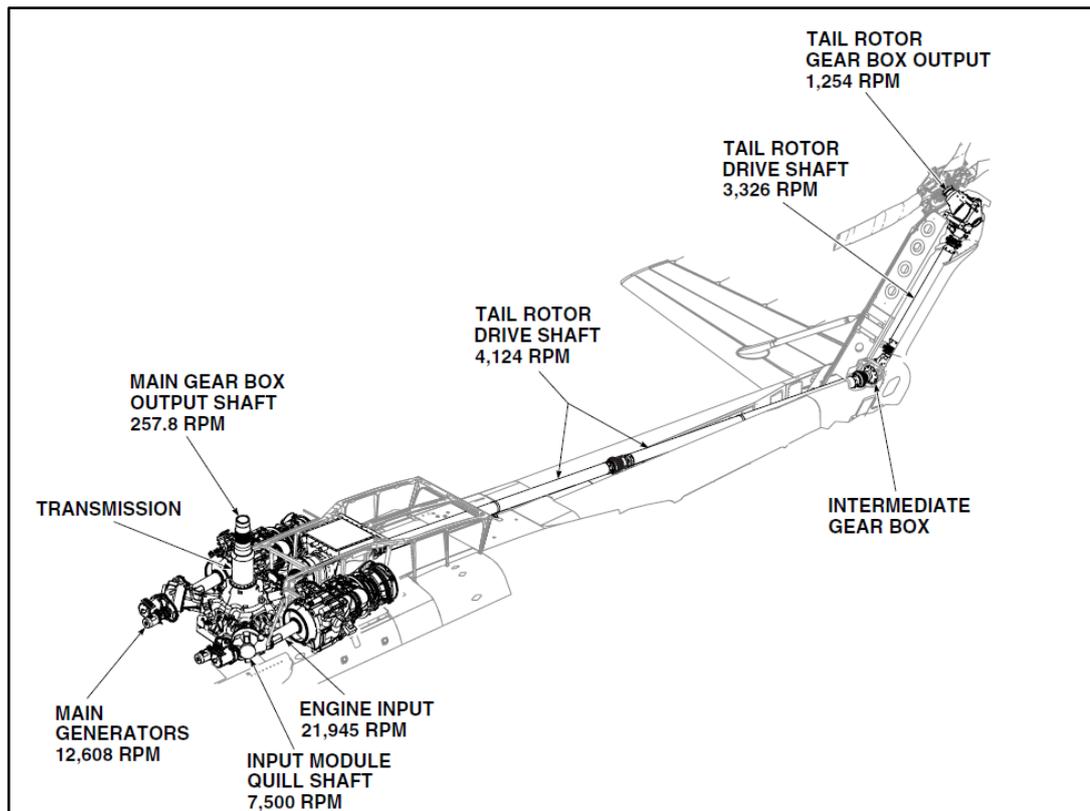
Figure No. 1: S-92A Rotor Drivetrain

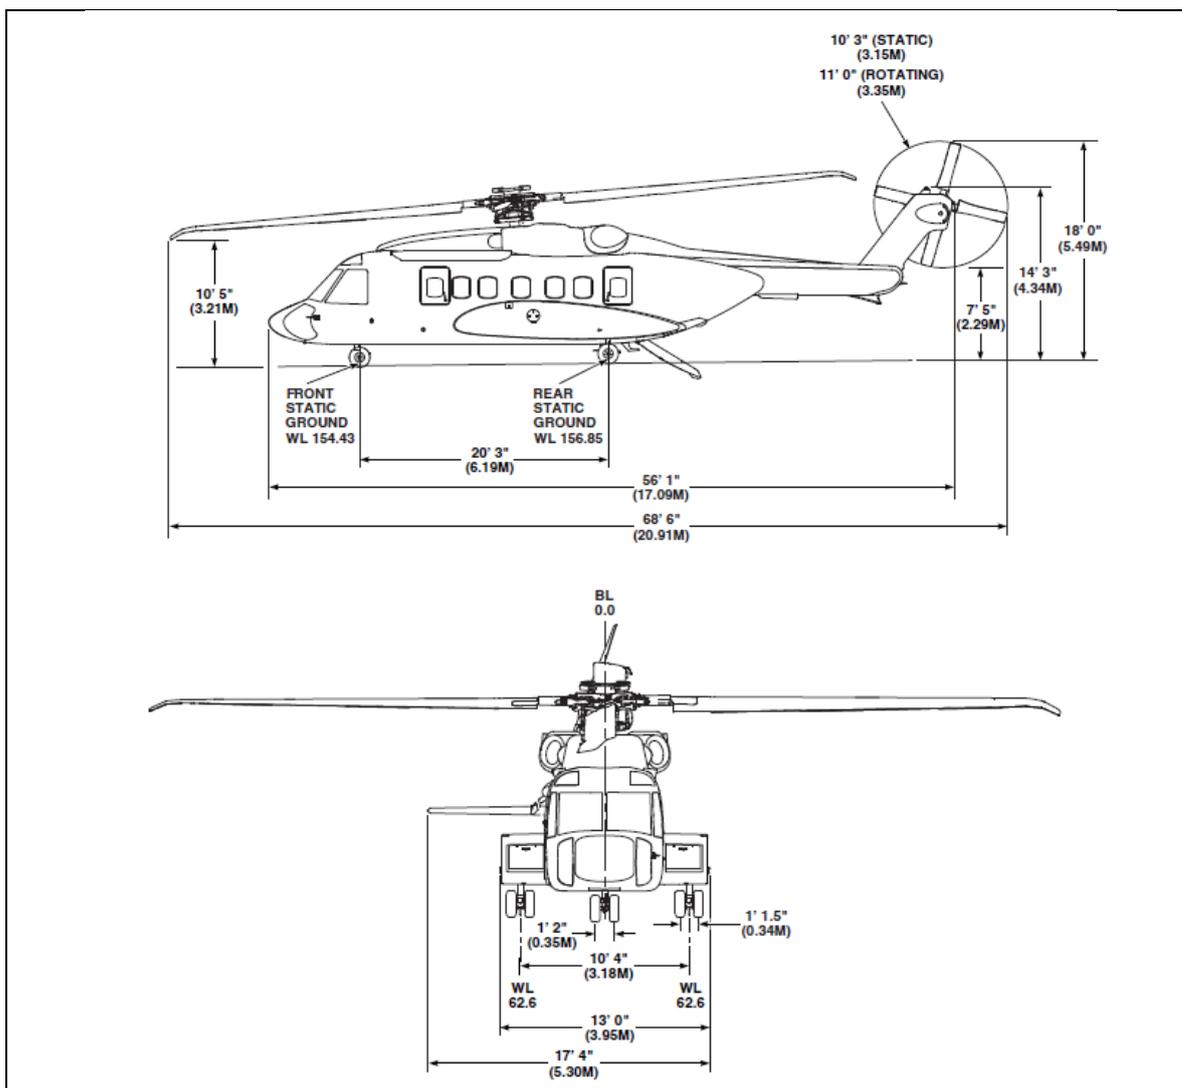
Figure No. 2: The principal dimensions of the S-92A helicopter

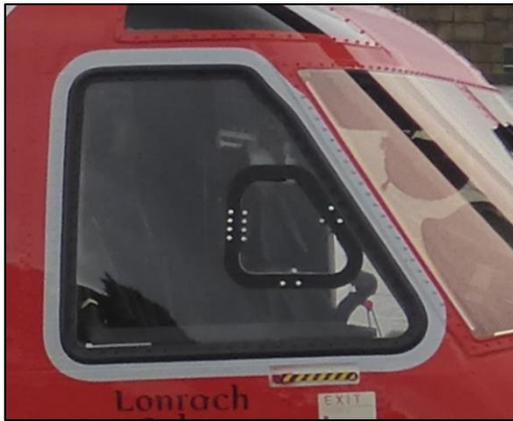
Photo No. 2

In addition to the main sliding door on the right hand side of the cabin and the rear ramp door, three cabin emergency exits are fitted. The three cabin emergency exits can be jettisoned by rotating the interior or exterior release handle. The upper section of the air stair door can be opened by using the locking handle. Pushout cabin windows are also provided. These windows can be jettisoned by pushing on the window from inside the cabin. To facilitate emergency egress from the cockpit, the pilots' windows can be jettisoned by rotating the interior emergency release handle aft or by pressing the red button and rotating the exterior release handle counter-clockwise (**Photo No. 2 and 3**).

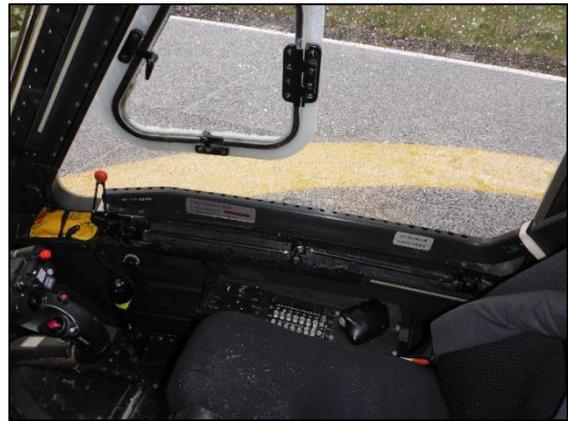
Photo No. 3

Right hand side pilot's emergency exit window

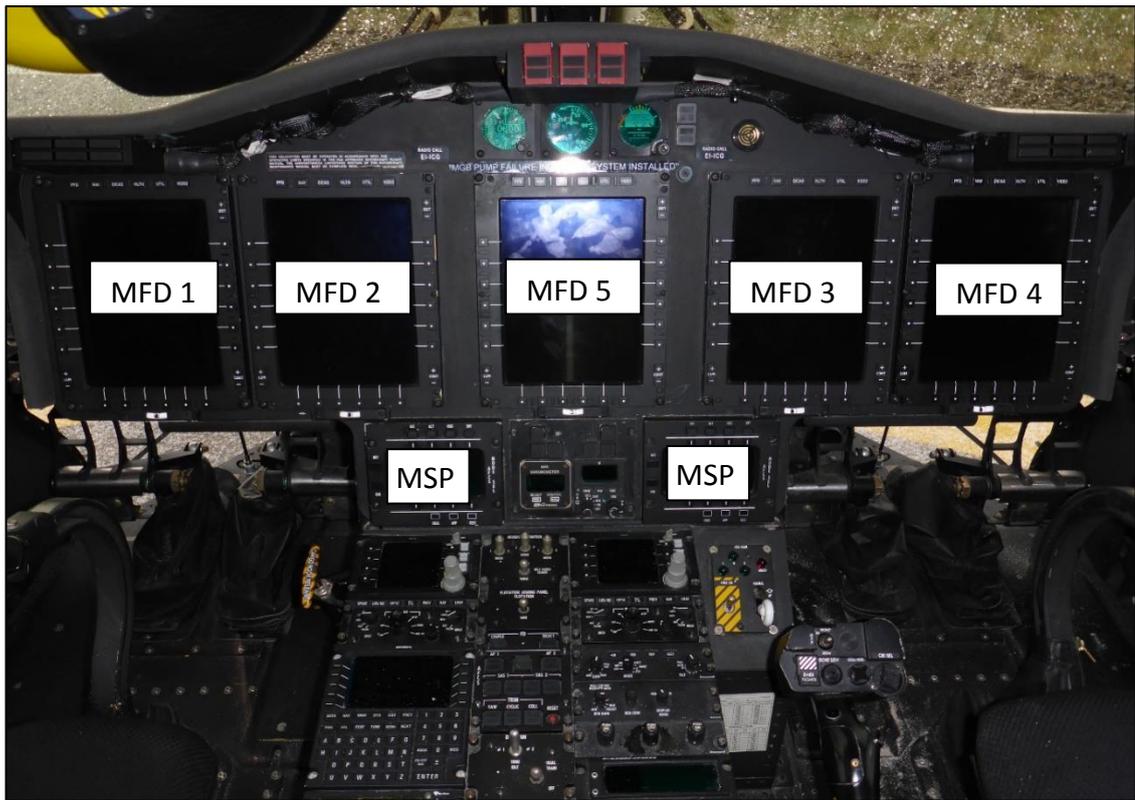
The Rockwell Collins Avionics Management System (AMS) consists of five Multi-Function Displays (MFD), two Mode Select Panels (MSPs) and two Data Concentrator Units (DCUs) (**Photo No. 4**).

Photo No. 4: Cockpit Displays and Control Panels

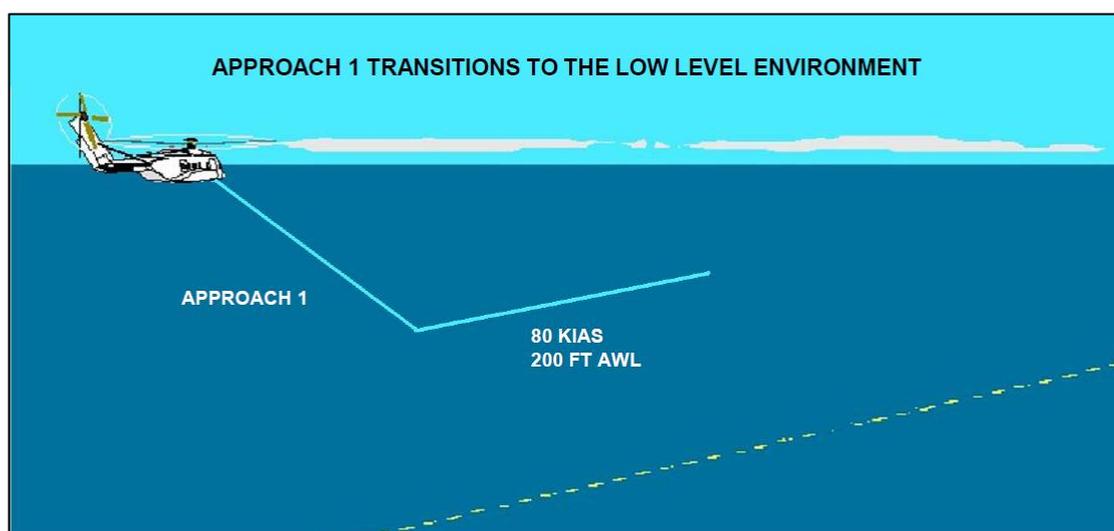
Descent from cruise flight is made with 'ALT P' mode, using barometric altitude. Below 2,400 ft, with the RAD ALT active, the SAR approach modes are available. One of these SAR modes, Approach 1 (APP1), automatically transitions the helicopter from flight below 2,400 ft to low level operations. Once initiated, the helicopter will intercept the altitude/airspeed line and continue down 200 ft Above Water Level (AWL) and 80 KIAS (**Figure No. 3**).

Figure No. 3: SAR Mode APP1 (APPROACH 1).

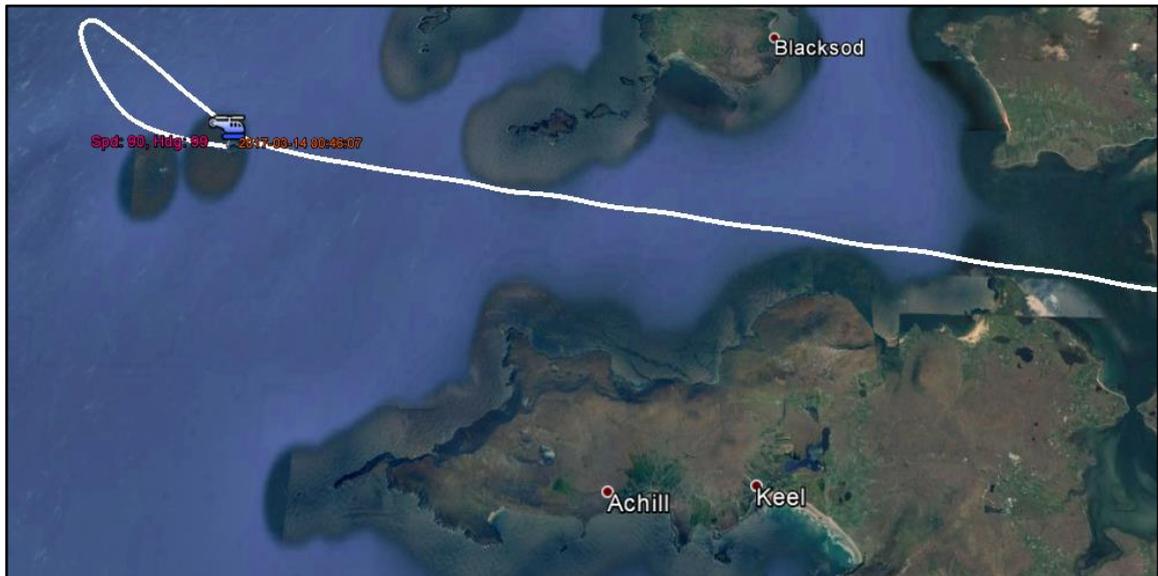
For the purposes of orientation in this Preliminary Report the Investigation overlaid the AIS track information on “Google Earth” to produce two images showing an overview of the helicopter track (**Figure No. 5**) in the general Blacksod area and a close up of the final seconds of the track (**Figure No. 6**) and the terrain of Black Rock.

Figure No. 5: Overview of helicopter track in the general Blacksod area

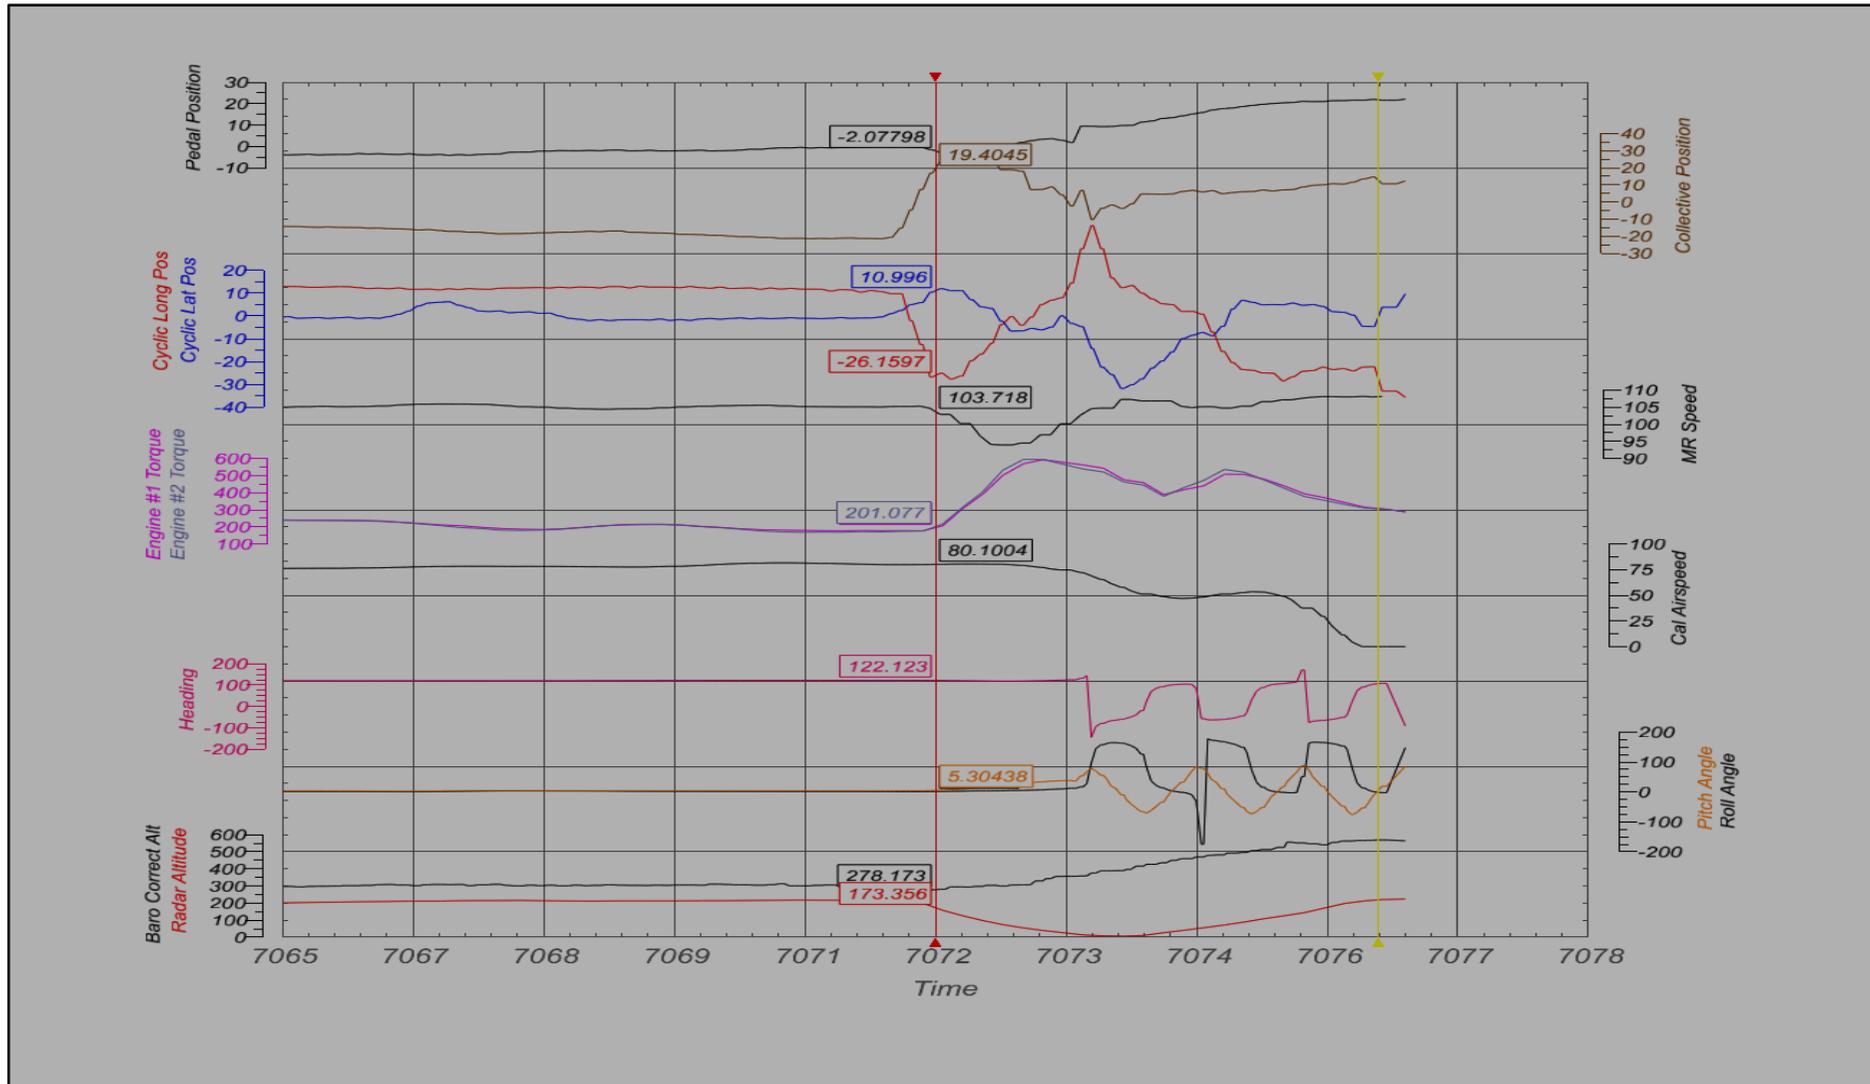
Appendix B
A selection of recorded data from the final seconds of FDR data
