Air Accident Investigation Unit Ireland

FACTUAL REPORT

**Piper J5A (Cub Cruiser), EI-AXT
Near Shantonagh, Co. Monaghan, Ireland**

13 September 2016

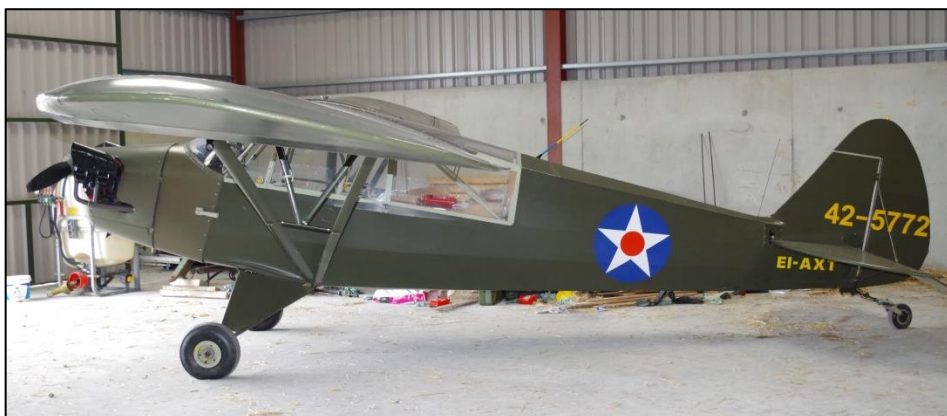
The tail-wheel aircraft, a Piper J-5A, was a high-wing, strut-braced monoplane, with a wing span of 35 feet and 5.5 inches (10.8 m) (**Photo No. 2**). It was manufactured in 1940 and was fitted with a Rolls-Royce/Continental O-200-A engine, which powered a two-bladed fixed-pitch propeller. The fabric-covered fuselage had a welded tubular steel frame. The aircraft had seating for three people—the Pilot in front and two side-by-side passengers in the rear.

Photo No. 2: EI-AXT (registration markings are in accordance with an IAA-issued exemption)
