Air Accident Investigation Unit Ireland

FACTUAL REPORT

HATZ CB1, G-BRSY

Coonagh Airfield (EICN)

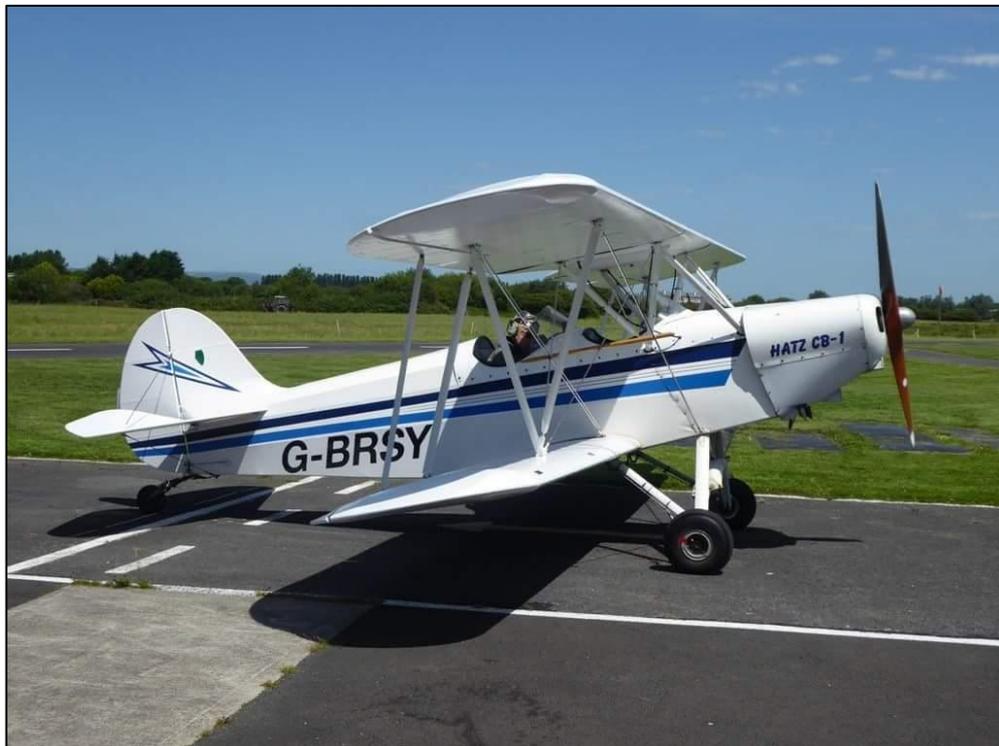
The HATZ CB-1 is a light biplane designed in the 1960s for amateur construction. G-BRSY was completed in 1978 (**Photo No. 2**). It had a tailwheel configuration and was fitted with a Lycoming O-290-D2 engine. The aircraft '*Permit to Fly - Certificate of Validity*' for the aircraft was issued by the UK Light Aircraft Association (LAA) on 25 October 2017.

Photo No. 2: The HATZ CB-1
