# Air Accident Investigation Unit Ireland

**SYNOPTIC REPORT**

**Airbus A330-202, EI-LAX**

**On Take-Off, Dublin Airport**

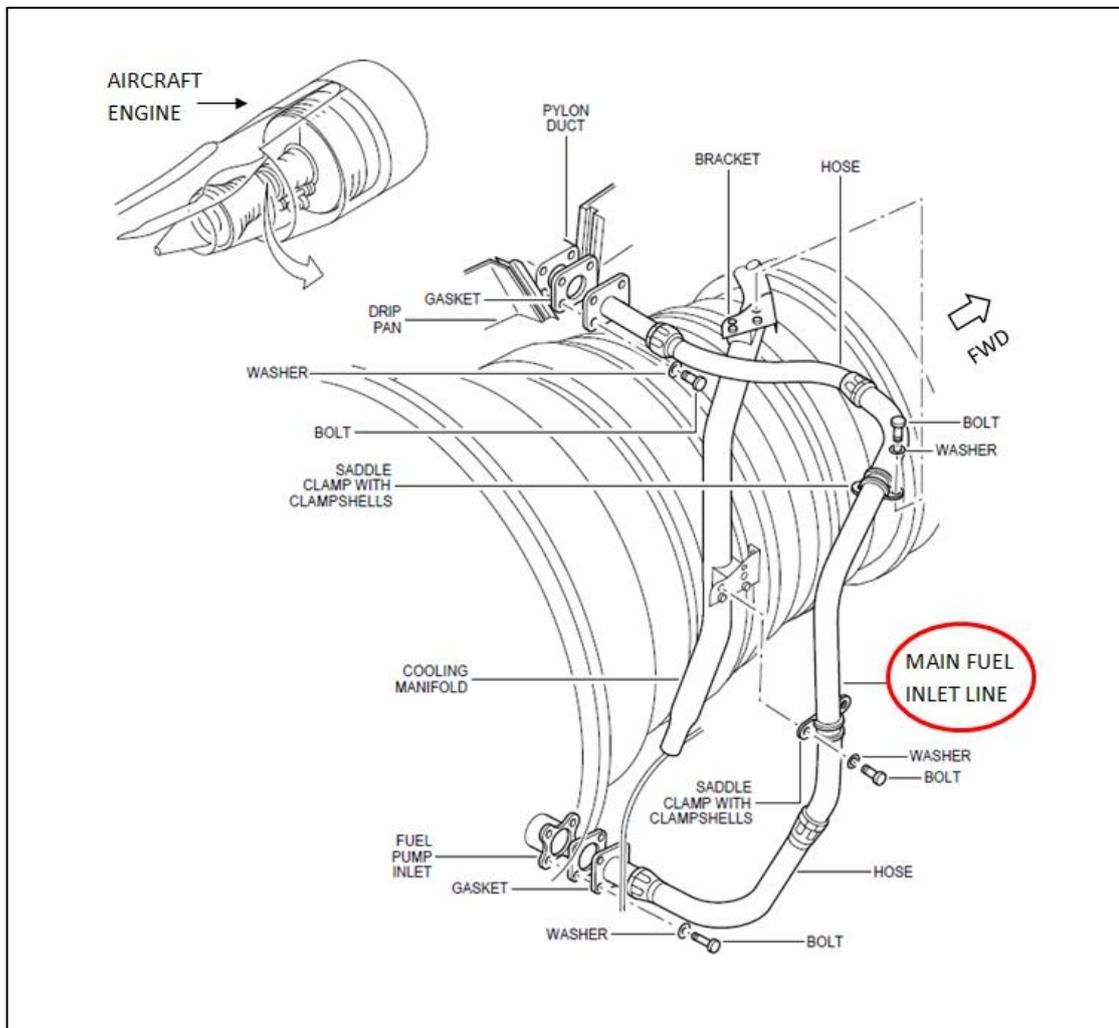
The following applies to each engine: The main fuel inlet line is routed circumferentially around the right-hand side of the engine (aft, looking forward), from a connection in the engine pylon, to the fuel pump inlet on the lower part of the engine (**Figure No. 2**). The fuel line is made up of solid and flexible sections. Each flexible section consists of a hose, supported internally by a metal coil and covered externally by a woven wire braid, which is in turn covered by a layer of silicone rubber. Part of the fuel line is located within close proximity to the 14<sup>th</sup> stage manifold.

**Figure No. 2:** Location of main fuel inlet hose assembly (adapted from the Aircraft Manufacturer's Aircraft Maintenance Manual (AMM) 73-11-00)

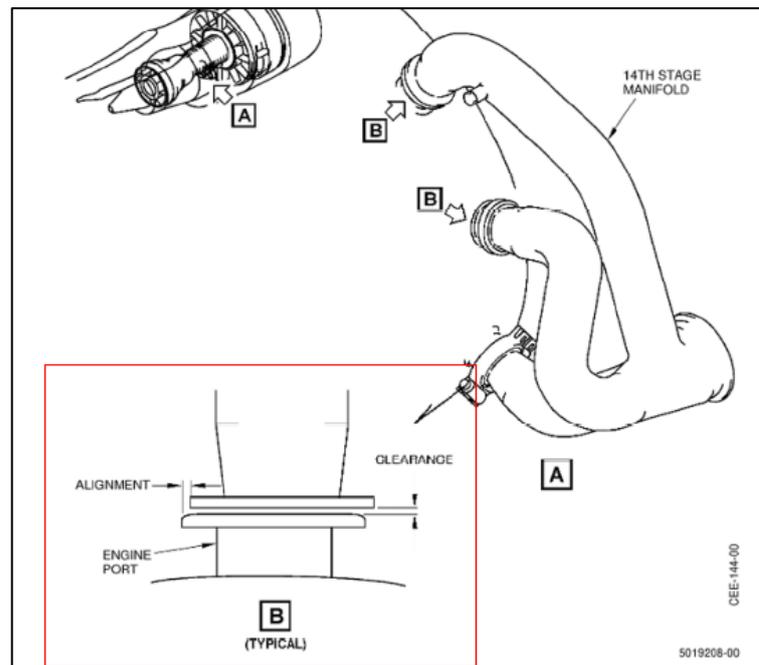
The task card for the installation of the 14<sup>th</sup> stage manifold also contains instructions (with reference to the Engine Manual) regarding the correct alignment of the manifold during the installation procedure and the correct torque to be applied when tightening the couplings. The referenced Engine Manual section (71-00-02, dated 15 March 2017) instructs technicians to fit the manifold to the lower bleed port and to tighten its coupling sufficiently to hold the manifold in position and then check the clearance and offset at the two other ports (**Figure No. 3**). The Engine Manual states that the maximum permitted clearance at the centre and upper ports is “0.020 inch (0.50 mm)” and the maximum permitted alignment offset is “0.060 inch (1.52 mm)”. The task card includes a specific section to record these measurements following installation. The clearance is recorded as “0.008” [inch]. The offset is recorded by what appears to be 0.025 inch (i.e. within Engine Manual limits).

**Figure No. 3:** Manifold installation instructions regarding clearance and alignment

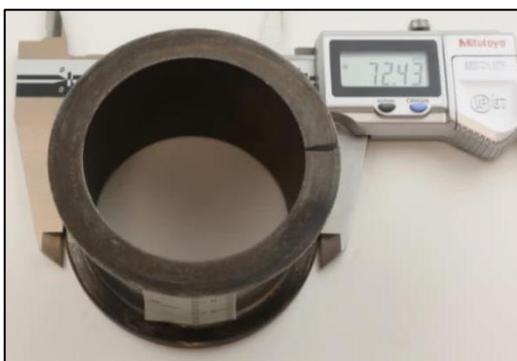
The Investigation examined the minimum and maximum dimensions of the outside diameter of the flange of the fractured spacer to determine if any distortion (out-of-roundness) was evident (**Photo No. 7** and **Photo No. 8**). The maximum out-of-roundness was found to be 0.25 mm (72.11 mm - 71.86 mm). The out-of-roundness of the flange of an exemplar spacer was also evaluated (**Photo No. 9** and **Photo No. 10**). The maximum value was 0.19 mm (72.43 mm - 72.24 mm). The Engine Manufacturer’s component specifications did not contain a tolerance for out-of-roundness. However, the specifications included a manufacturing tolerance for the spacer’s outside diameter of +/- 0.010 inch (0.25 mm) and a maximum *“run-out”* between one diameter and another diameter concentric to the same axis of 0.005 inch (0.127 mm).

**Photo No. 9:** Maximum diameter of exemplar spacer flange (72.43 mm)

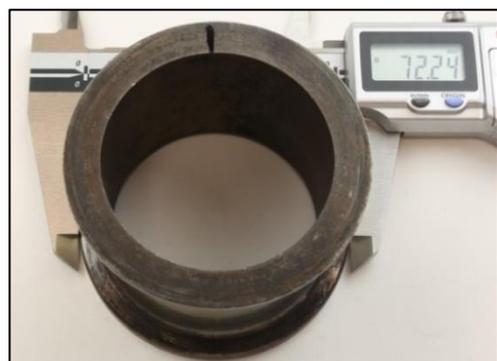
**Photo No. 10:** Minimum diameter of exemplar spacer flange (72.24 mm)
