Air Accident Investigation Unit Ireland

SYNOPTIC REPORT

**Cessna F172P Skyhawk, EI-ING
Near Craughwell Airfield, Co. Galway**

4 August 2018

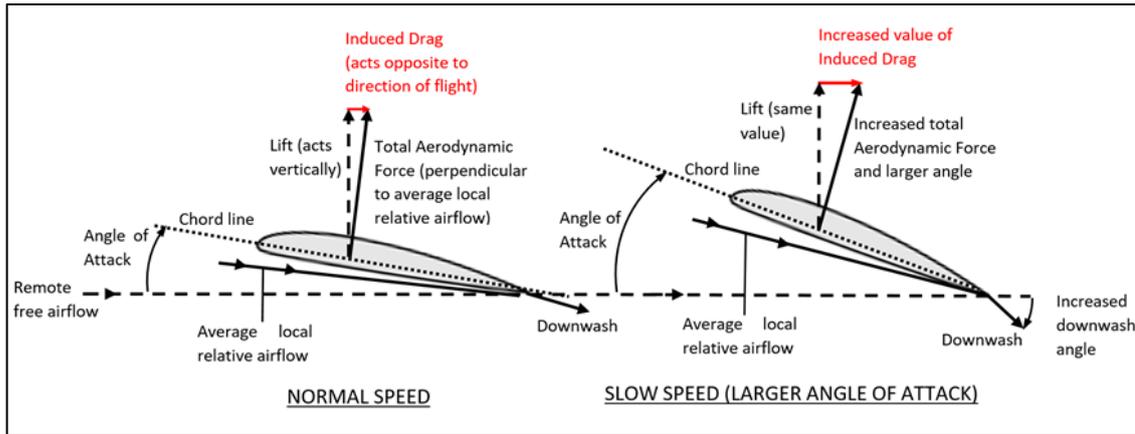
For a normal aircraft wing to produce lift, the air pressure above the wing will be less than the air pressure below the wing. As the air flows rearwards around the wing, some of the air will spill around the wingtip, from the higher pressure region at its lower surface to the lower pressure region at its upper surface. There is an associated span-wise flow of air from wing root to wingtip on the lower wing surface, and from wingtip to wing root on the upper wing surface. This span-wise airflow results in vortices being generated at the trailing edge of the wing and at the wing tip, where the vortices are strongest. The net effect of the vortices is a downwash behind the wing, which deflects the airflow downwards, causing the wing to experience a local airflow (i.e. an average relative airflow) and the total aerodynamic force generated by the wing to be tilted rearwards (**Figure No. 1**).

Figure No. 1: Induced drag greatest at slow speeds/larger angles of attack (based on Thom)

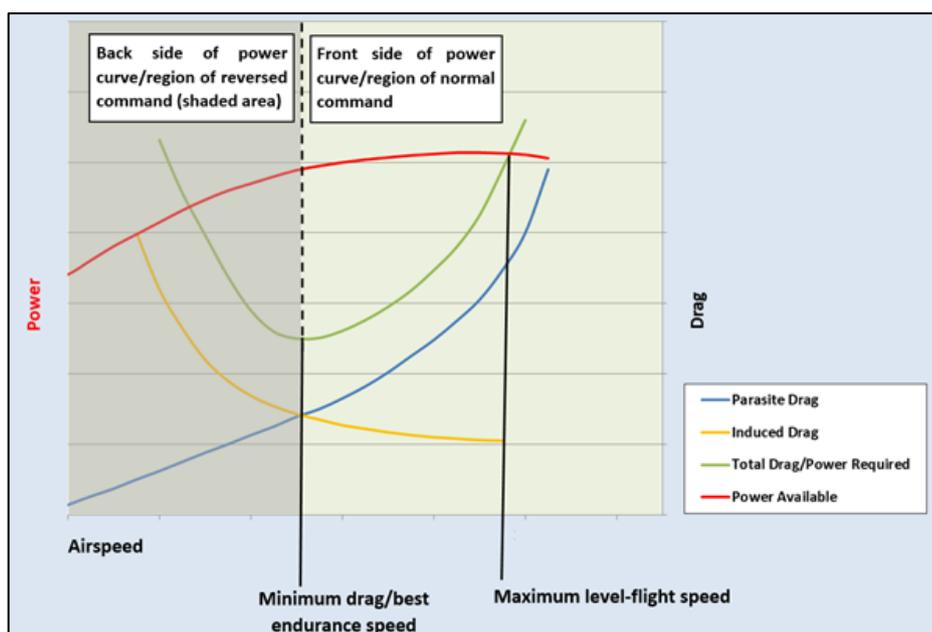
Figure No. 2: Power and drag curves (Illustrative only)

As outlined earlier, induced drag is greatest at slow speeds/large angles of attack (yellow line in **Figure No. 2**), whereas parasite drag is directly proportional to the square of airspeed (blue line in **Figure No. 2**). In stable, level flight (equilibrium), lift equals weight and thrust equals drag. The green line in **Figure No. 2** represents the total drag (induced + parasite), and therefore the power required. The red line represents the power available. The difference between the power required and the power available (excess power) can be used, to accelerate or to climb. There is no excess power available where the red and green lines cross.

The shaded area in **Figure No. 2** is known by various terms, including *'the back side of the power curve'*, *'the back of the drag curve'* or *'the region of reversed command'*. When operating in this region, the lower the airspeed, the more power that is required to maintain altitude. This is because of the increased induced drag at low airspeeds due to the larger angle of attack needed to maintain sufficient lift. If the angle of attack is further increased by pulling back on the yoke, induced drag will increase and the aircraft will descend unless more power is added. When no more power is available, level flight is not possible and the aircraft will descend. The only way to increase airspeed, and therefore lift, is to lower the nose of the aircraft and descend. This is not an option when close to the ground.
