Air Accident Investigation Unit Ireland

FACTUAL REPORT

**BRM, Land Africa (Citius), EI-FBY
Ballyheelan, Co. Cavan**

21 April 2021

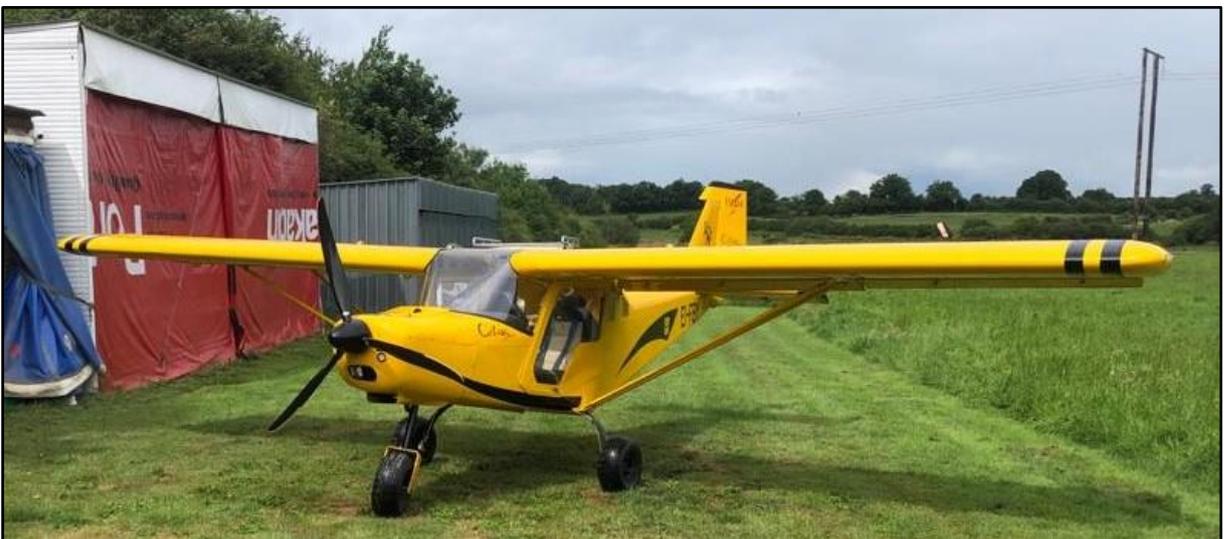
Photo No. 1: General view of the aircraft (*Source: The Pilot*)

The aircraft, a Land Africa (Citius), was manufactured by BRM Construções Aeronáuticas LDA, in 2008, and registered in Ireland in the microlight aeroplane category on 5 July 2013 as EI-FBY (**Photo No. 1**). The aircraft was powered by a 73.5 kW BRP-Rotax 912 ULS piston engine driving a Kiev 283 three-bladed propeller. The aircraft's flight permit was issued by the Irish Aviation Authority (IAA) on 27 May 2019. The first extension to the flight permit validity was certified on 4 May 2020 and was valid until 26 May 2021. The maximum take-off mass was 450 kg and the stall speed published by the manufacturer was 45 km/h⁸.
