Air Accident Investigation Unit Ireland

SYNOPTIC REPORT

**Thruster, T600N-450, EI-GOE
Woolengrange, Co. Kilkenny**

AAIU Report No: 2022 - 007

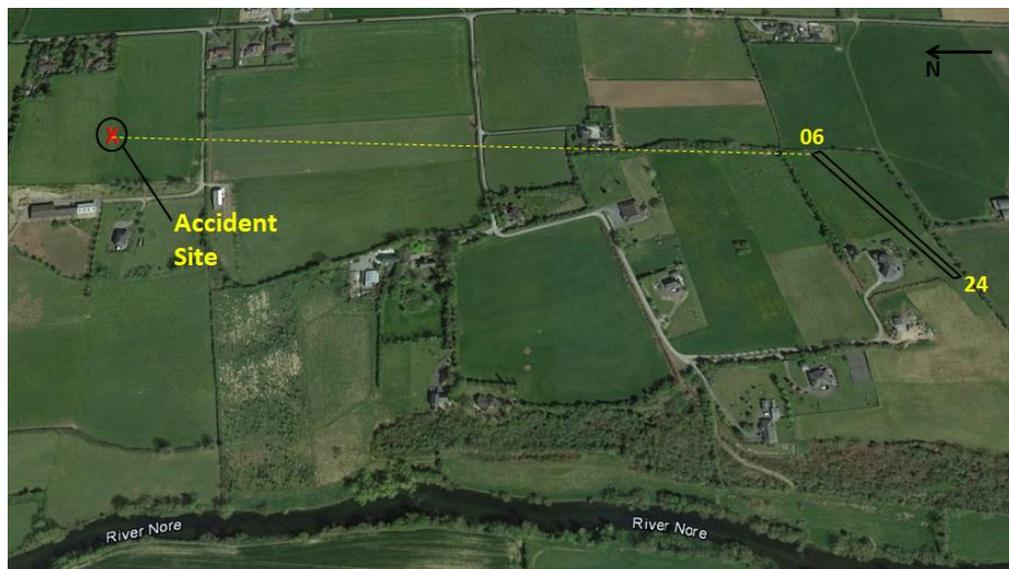
Figure No. 1: Airstrip and Accident Site (Google Earth)

The aircraft was operating from a private grass airstrip located in the Woolengrange area of Co. Kilkenny. The single grass runway is oriented on reciprocal magnetic bearings of 060/240 degrees and is approximately 200 metres (m) in length and 15 m in width. The accident site was situated approximately 760 m to the north of the end of the runway (RWY 06) as indicated by the dashed yellow line in **Figure No. 1**.

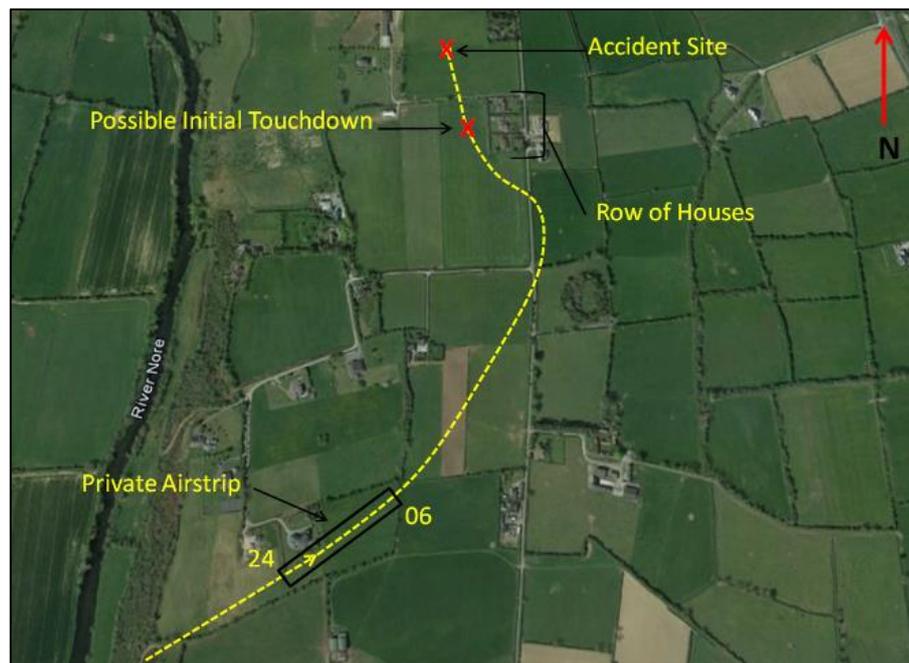
Figure No. 2: Estimated flightpath of EI-GOE

Based on witness reports, combined with details provided by the Pilot, the estimated flightpath of the aircraft between completion of the low level pass on RWY 06 to the point of impact is illustrated in **Figure No. 2**. The accident site is located approximately 760 m north of the end of RWY 06.

Witness reports had suggested that the aircraft initially touched down briefly in the field adjacent to the accident site; however, the Pilot did not recall such an initial touchdown and an inspection of the field did not identify any touch down points.
