Air Accident Investigation Unit Ireland

FACTUAL REPORT

**Reims Aviation SA, Cessna F172M, EI-DDC
Navan Airfield, Co. Meath**

4 March 2022

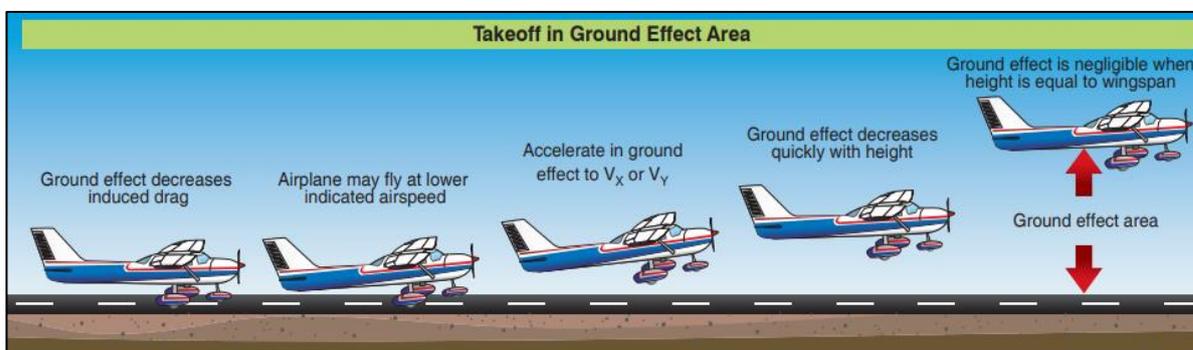
Figure No. 2: Take off in ground effect (FAA Airplane Flying Handbook)

Wingtip vortices behind the trailing edge are a major cause of induced drag⁸ so when a nearby surface restricts their formation, the induced drag will be less and therefore the total drag on the aircraft will be less. An aircraft operating with reduced power may be able to maintain flying speed while in ground effect; however, once out of ground effect this may not be possible. When an aircraft climbs to a height above the ground, equivalent to approximately one wingspan, an aircraft is effectively out of ground effect (**Figure No. 2**) and if the aircraft is at a high angle of attack, induced drag will also be high. If an aircraft becomes airborne at too low a speed, it may be unable to climb further due to a combination of reducing ground effect and high induced drag.

Because the Cessna 172 is a high-wing aircraft, the downwash generated by the wings can act on the tail of the aircraft. Therefore, when the aircraft climbs out of ground effect, in addition to the decrease in lift and increase in induced drag as the downwash increases, the effect of the downwash on the horizontal stabiliser becomes progressively stronger. This can cause a downward load on the horizontal stabiliser and a nose-up pitching moment.
