FINAL REPORT

AAIU Synoptic Report No: 2010-013

Aircraft Type and Registration:	Pipistrel Taurus 503, EI-ECS
No. and Type of Engines:	1 x Rotax 503 UL
Aircraft Serial Number:	039
Year of Manufacture:	2008
Date and Time (UTC¹):	06 December 2008 @ 16.04 hrs
Location:	Near Birr Airfield, Co. Offaly, Ireland N53° 04.53', W008° 53.97'
Type of Flight:	General Aviation – Check flight
Persons on Board:	Crew – 1 Passengers – 1
Injuries:	Crew – Nil Passengers – Nil
Nature of Damage:	Damaged beyond economical repair
Commander's Licence:	JAA PPL (M)
Commander's Details:	Male, aged 46 years
Commander's Flying Experience:	974 hours, of which 0 were on type
Notification Source:	Gardaí at Birr
Information Source:	AAIU Field Investigation

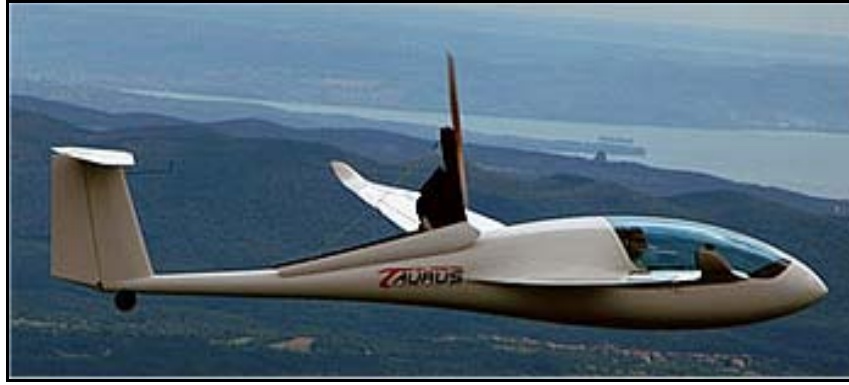
Photo No. 3: Taurus (copyright Pipistrel)

The Taurus is a mid-wing, high aspect ratio, T-tail, tail dragger motor glider, constructed mainly from a Kevlar, carbon, and glass fibre composite (**Photo No. 3**). Two side-by-side seats are provided in a cockpit that is covered by a bubble canopy. The wings can be removed for storage by removing two large spar pins that interlock the main spar of each wing. The twin undercarriage main wheels are retractable while the tail wheel castors.
