# Air Accident Investigation Unit Ireland

**ACCIDENT REPORT**  
**Irish Air Corps 265, PC-9(M)**  
**Cornamona, Connemara, Co. Galway**  
**12 October 2009**

AAIU Formal Report No: 2011-016

Operator:	Irish Air Corps (IAC)
Manufacturer:	Pilatus Aircraft Ltd
Model:	PC-9(M)
Nationality:	Ireland (Military)
Registration:	265
Location:	Crumlin East, Cornamona, Connemara, Co. Galway, Ireland N53°32.192' , W009°30.436'
Date/Time (UTC <sup>1</sup> ):	12 Oct 2009 @ 16.57 hrs

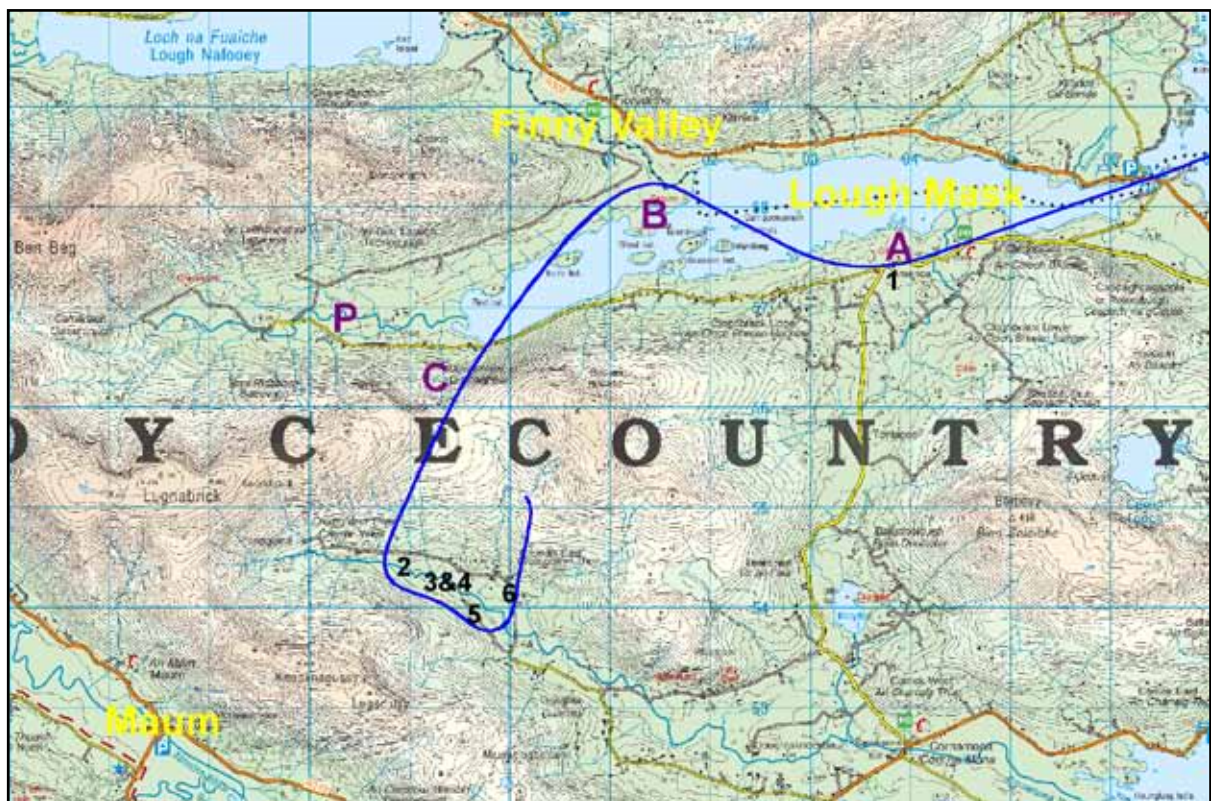
**Figure No. 1:** Track of F265 and witness locations

Witness No. 1 (**Figure No. 1**) was located on the south-western shore of Lough Mask, to the northeast of Crumlin Valley, and observed the aircraft from his house at about 16.50 hrs. He saw it turning right, to the northwest, towards a valley and "into cloud". This was the only witness of F265 who was not located in Crumlin Valley.

**Note:** The blue track in **Figure No. 1** is the track<sup>7</sup> flown by F265. Witness positions are numbered.

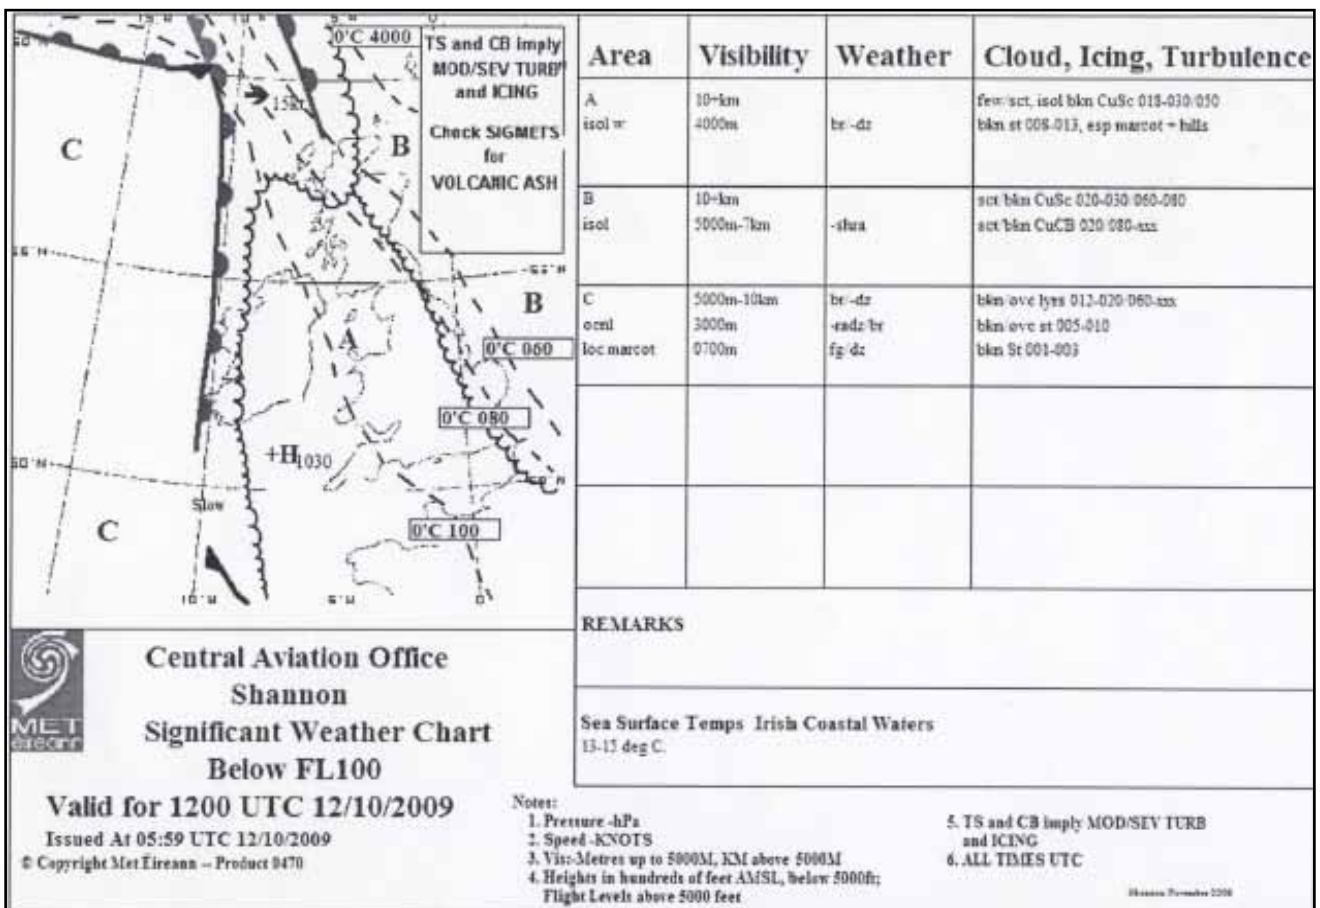
Figure No. 6: 12.00 hrs Low Level Significant Weather Forecast (Met Éireann)

Probably the most important chart for planning this low level flight was the Low Level Significant Weather chart. The earlier chart for 12.00 hrs (**Figure No. 6**) showed a warm front approaching the West Coast of Ireland.

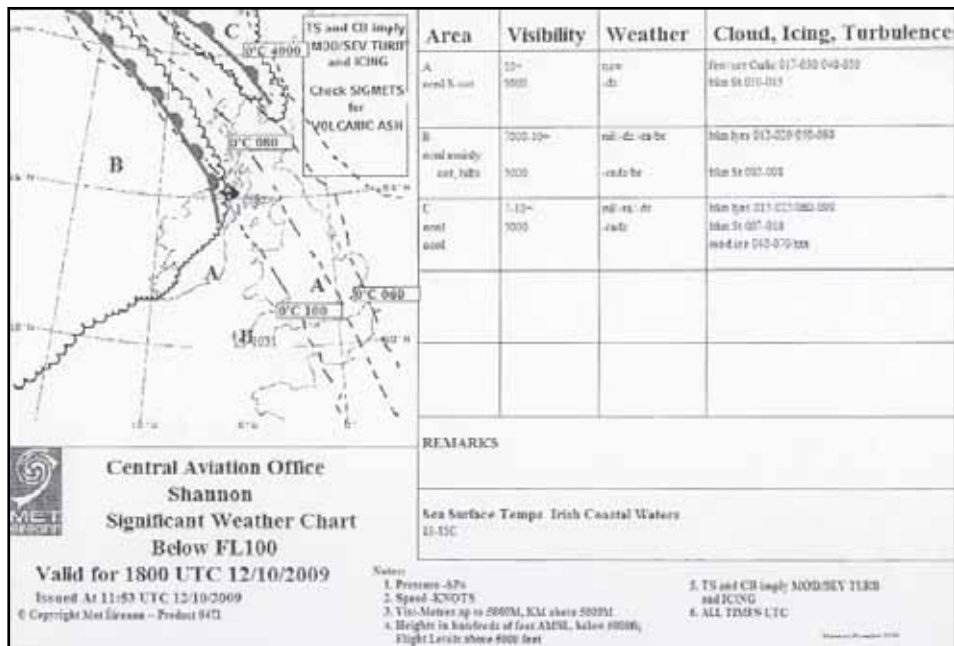
**Figure No. 7: 18.00 hrs Low Level Significant Weather (Met Éireann)**

The later low level significant chart for 18.00 hrs (**Figure No. 7**) forecasted that the warm front would have passed the West of Ireland, but the general area (B) still shows a misty aftermath of stratus cloud with light rain or drizzle and little improvement in the general weather conditions.

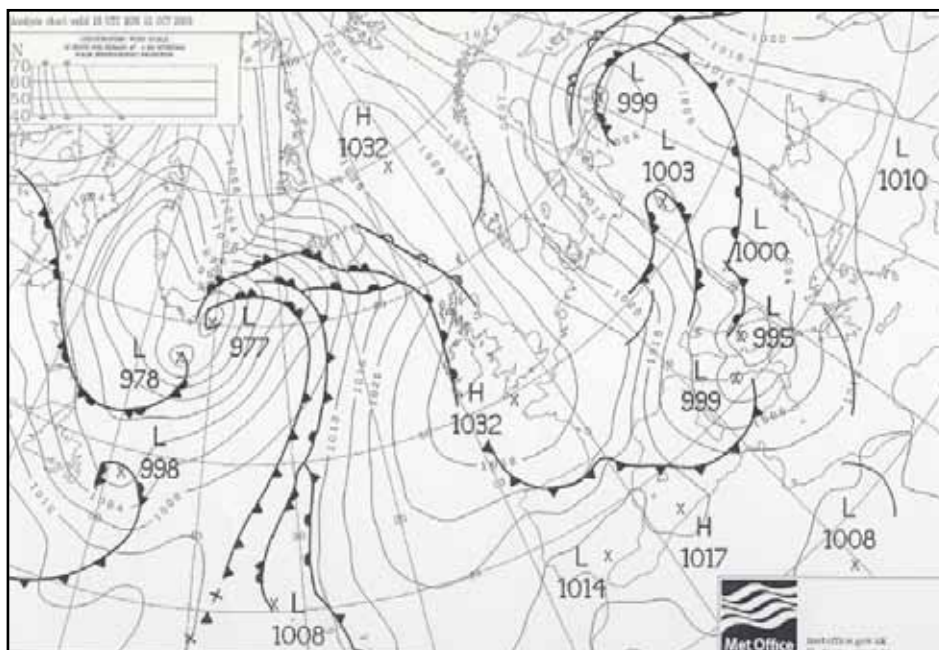
**Figure No. 8: Synoptic Forecast for 18.00 hrs (UK Met Office)**

The Synoptic Forecast for 18.00 hrs issued by the UK Met Office shows the front still over the West of Ireland (**Figure No. 8**).

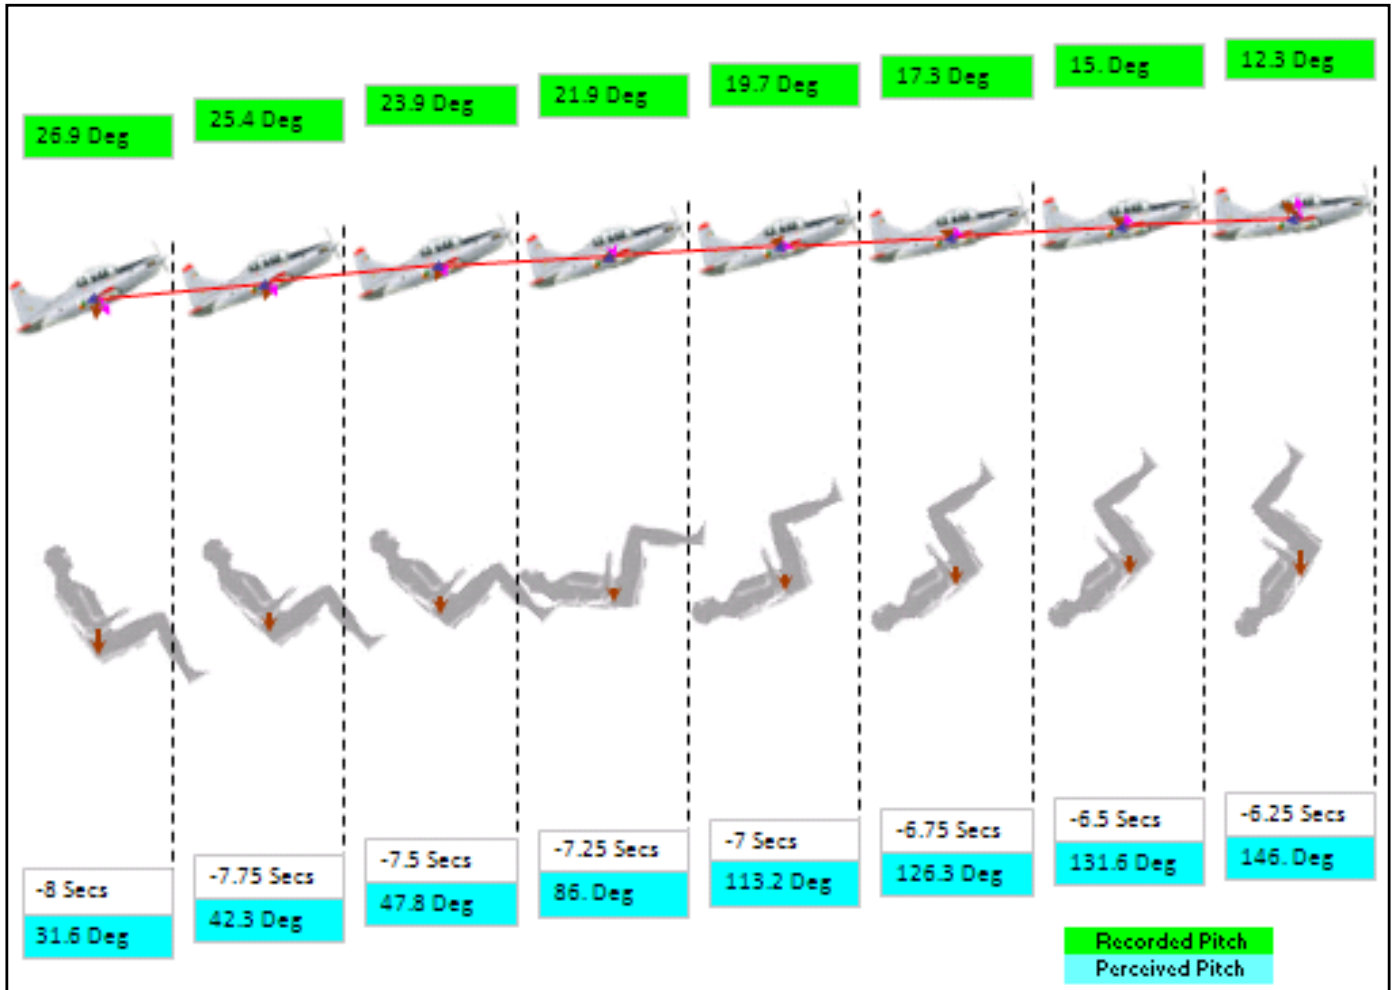
Figure (v): Emergence of False Pitch and Inversion Illusions (Large)

This abrupt change in the direction of the force vector may have given the Pilot the feeling that the aircraft was continuing to pitch upwards after he had eased off on the stick and at a time when he would have expected it to have stopped doing so (as indeed it had). This may have been the erroneous indication to the Pilot that a further stick forward control was required, leading him to begin to push-over the aircraft some 2 seconds later at -8 sec and by -7 sec the Gz vector had become negative.

This analysis of perceived pitch rates may provide the sensory stimulus to explain the Pilot's initial stick forward action, which then became self-perpetuating for the reasons explained above. This effect can be seen by closely studying **Figure (ii)** and comparing the actual aircraft pitch and the perceived aircraft pitch between -10.5 seconds and -9.75 seconds. **Figure (vii)** shows the actual and perceived pitch along with the Elevator Position (a linear function of stick forward (negative)/aft (positive) position, which further illustrates and supports the hypothesis regarding the stimulus for push-over initiation.
