**AIR ACCIDENT
INVESTIGATION UNIT**

THIS IS A REFORMATTED VERSION OF
THE ORIGINAL REPORT ON
ACCIDENT TO
VISCOUNT 803 AIRCRAFT EI-AOM
NEAR TUSKAR ROCK, CO. WEXFORD
ON 24th MARCH, 1968

REPORT ON AN INVESTIGATION
MADE UNDER REGULATION 7 OF THE
AIR NAVIGATION (INVESTIGATION OF ACCIDENTS)
REGULATIONS, 1957 (S.I. No. 19 of 1957)

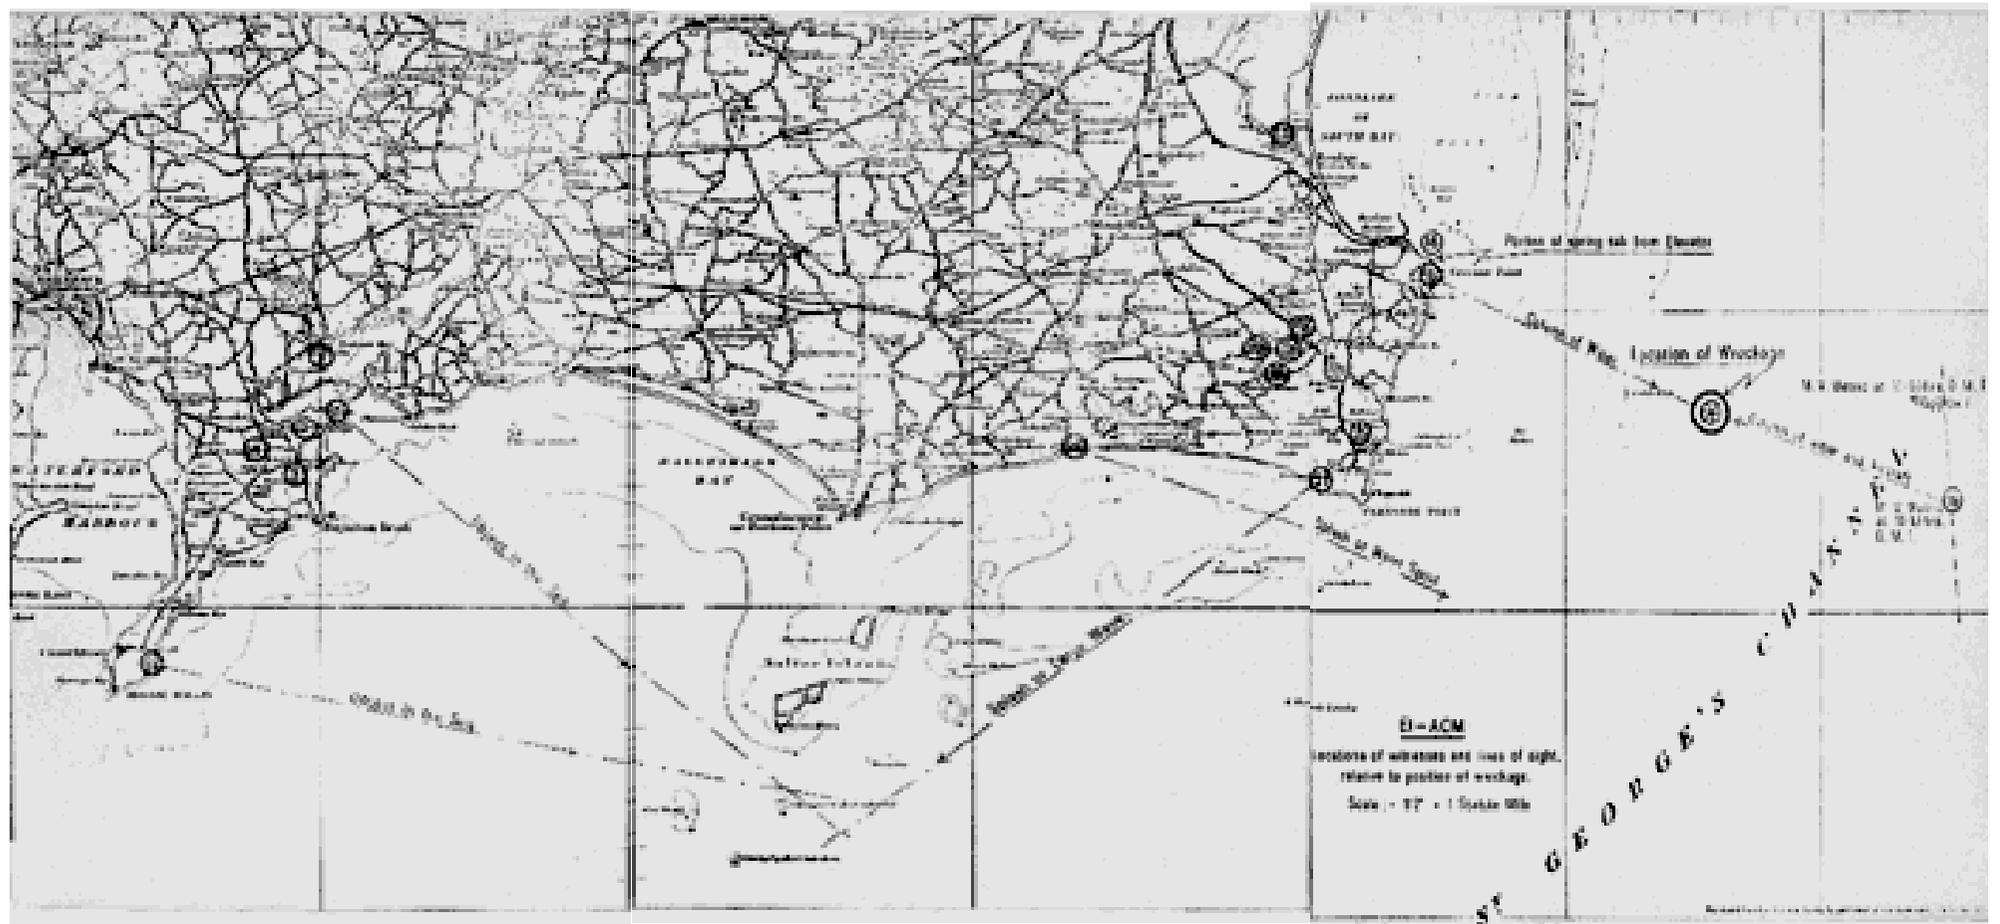
3. Map showing the general area of the accident and locations of witnesses to whom reference is made in the Report.

The attachment to the Report, a map of the general area of the accident, was originally published in approximately A2 size. To facilitate the reader, this version of the Report contains this map in two formats.

The first format is the map reduced to a single A4 size, so that the complete map can be viewed. This, however, results in some loss of detail.
