Air Accident Investigation Unit Ireland

SYNOPTIC REPORT

SERIOUS INCIDENT

**Cessna 172N, EI-CUJ
Cessna 172R, G-GFSA
Cork Airport, Ireland**

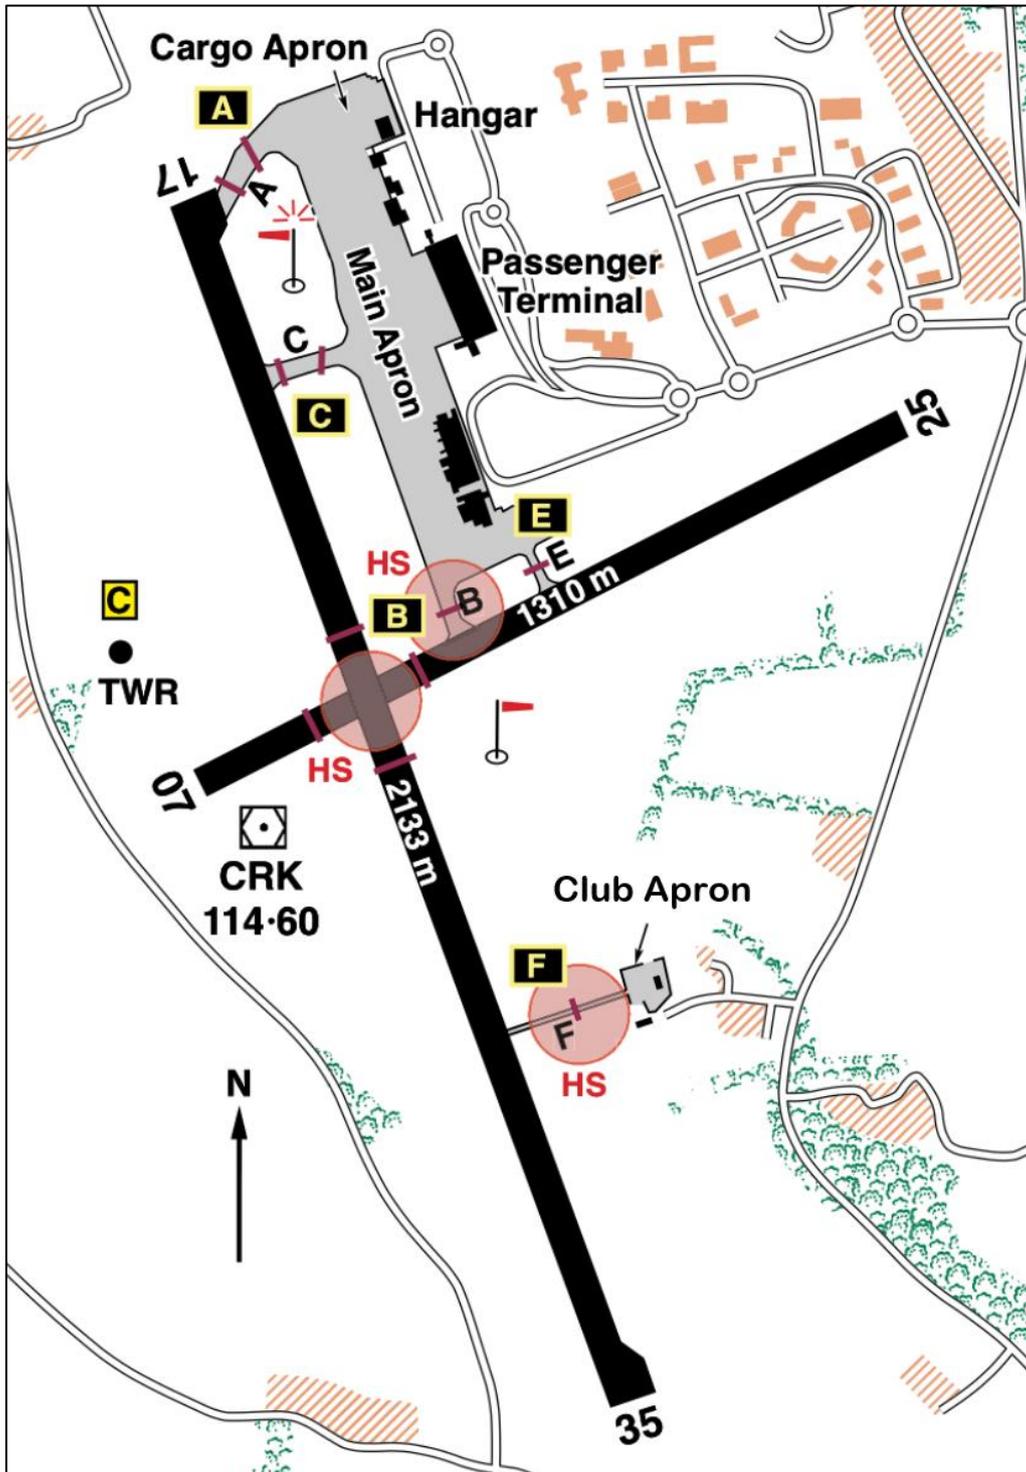
Appendix A
Chart of Cork Airport showing Runways, Taxiways,
Tower position (TWR) and Hotspot areas (HS)

(Based on *Pooleys (Ireland) 2017*)
