FINAL REPORT

AAIU Report No: 2010-008
State File No: IRL00908045
Published: 15/07/2010

Aircraft Type and Registration:	Airbus A319-132, D-AGWK
No. and Type of Engines:	2 x IAE V2524-A5
Aircraft Serial Number:	3500
Year of Manufacture:	2008
Date and Time (UTC):	27 May 2008 @ 11.45 hrs
Location:	30 nm east of Dublin
Type of Flight:	Scheduled Public Transport
Persons on Board:	Crew-6 Passengers - 119
Injuries:	Crew- Nil Passengers - Nil
Nature of Damage: Commander's	None
Licence: Commander's Details:	ATPL
Commander's Flying Experience:	Male, aged 34 years
Notification Source:	8,200 hours, of which 8,000 were on type
Information Source:	Dublin Air Traffic Control (ATC) AAIU Field Investigation

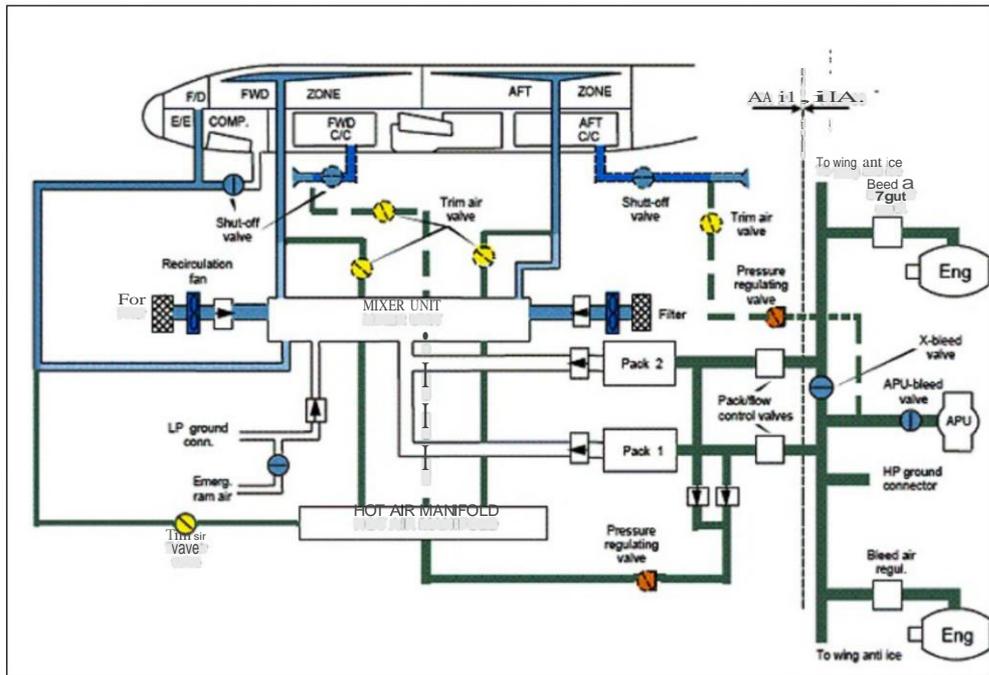
Appendix B

This diagram is a schematic layout of the air circulation system on the Airbus A319
